ON SITE INVESTIGATION AND MONITORING OF THE “TORRAZZO” OF CREMONA

L. BINDA¹, C. POGGI¹, G. MIRABELLA ROBERTI², R. TONGINI FOLLI¹
Politecnico di Milano¹, University of Reggio Calabria²

The Torrazzo of Cremona, the highest masonry tower in Europe shows signs of mechanical damage which can proceed toward risky state. The authors have carried out on site and laboratory investigation which ruled out short time risk but suggested the necessity of a long term monitoring to study the progress of the damage.

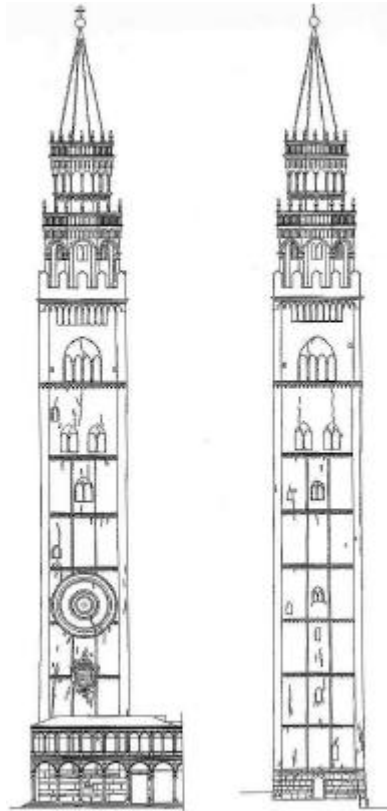
Figure 3: West and East side – crack

The presence of a diffused crack pattern particularly on the West, on the East side of the tower and on the *Ghirlandina* can indicate high states of stress due to the dead loads, the temperature variations and/or to a slight leaning. The highest temperature variations certainly occur between the North and the Southern side. In fact, the Western and Eastern sides have a diffused fissuration with passing-through cracks starting from approximately 20m up. Important cracks appear also between 48 and 60m from the ground level (Fig. 3). Fewer cracks appear in the Northern side (between 27 and 40m and at the NE corner) and in the Southern side (between 14 and 27m).

The *Ghirlandina* shows the most important cracks on the buttresses and on the brick columns particularly on the SW corner. Also the internal part of the tower, along the staircase and inside the rooms shows a diffused crack pattern with some passing through cracks.

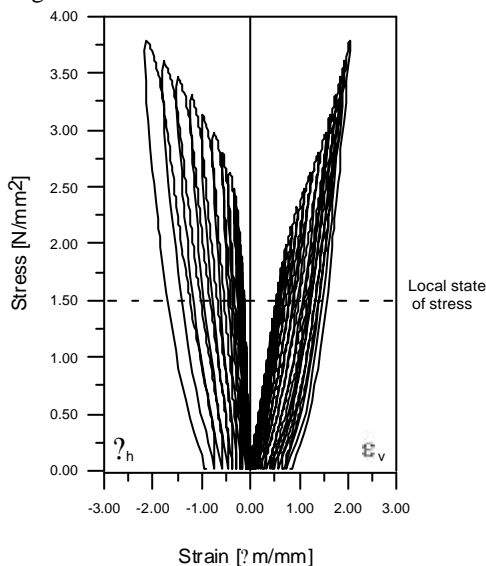
Figure 4: Stress-strain plot and state of stress

The results of the single jack tests show clearly two situations: a stress varying between 0.4 and 0.9 N/mm^2 where a detached leaf was found, a stress varying from 1.01 and 1.81 N/mm^2 where no detachment was detected, the higher values being found where the staircase reduces the section of the wall from 3.3 m to 0.7 m.

In Figure 4 the stress-strain plots are shown of a double flat-jack performed at 7.2 m level, together with the measured stress level.

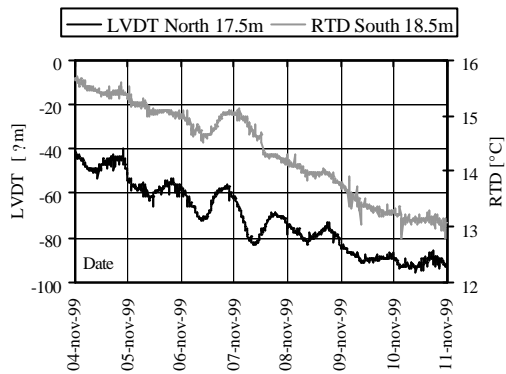
Figure 7: Temperature and crack opening correlation

Fig. 7 shows an example of the stored historical data for a 7 days period: a general descending temperature trend is superimposed to the day-night cycle and a clear correlation with the crack opening is recognisable.

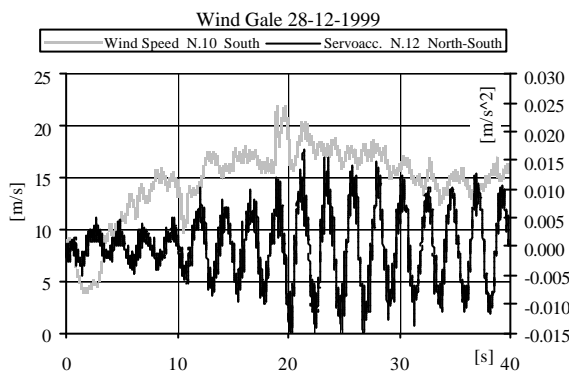
Figure 8: First mode excitation due to vortex shedding

A quite interesting example of the structure excitation by wind is shown in fig.8. Due to a sudden increase of the wind speed from 5 to 22m/s (then stabilising at 15m/s), a very clear forced oscillation pattern of the tower in its first mode (0.437 Hz) is recognisable. This is a typical example of forced oscillations due to vortex shedding excitation. Similar behaviours were found at different wind speeds, exciting structural modes at different frequencies.

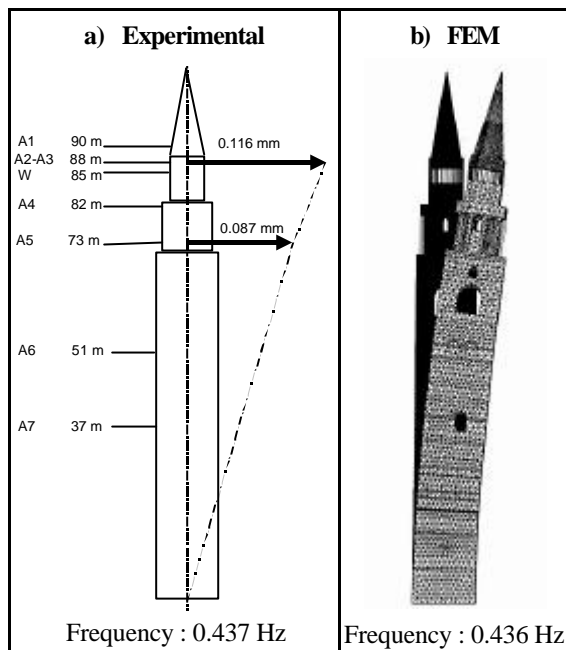
Figure 9: Numerical-experimental comparison (first flexural mode) and measurement sections layout (A = acceleration, W = wind).

As an example, Fig. 9 represents the first flexural vibration mode, corresponding to the deformations of fig. 8. They are compared to the corresponding FEM modal shape. The numerical model and the material characteristics can be calibrated against the real dynamic behaviour of the structure. In particular, Young's modulus, Poisson's coefficient, mass distribution and boundary conditions are typical turning parameters that can be adjusted to obtain the best numerical vs. experimental correspondence. The experimentally validated model can be a useful tool to analyse the structure static conditions and to provide useful information for reinforcement and repairing.
