# **RADAR AND SONIC AS COMPLEMENTARY AND/OR ALTERNATIVE TESTS IN THE SURVEY OF STRUCTURES.**

A. SAISI<sup>1</sup>, S. VALLE<sup>2</sup>, L. ZANZI<sup>2</sup>, L. BINDA<sup>1</sup>

<sup>1</sup>Department of Structural Engineering, Politecnico of Milan, Italy, <sup>2</sup>Department of Electronics and Information, Politecnico of Milan, Italy

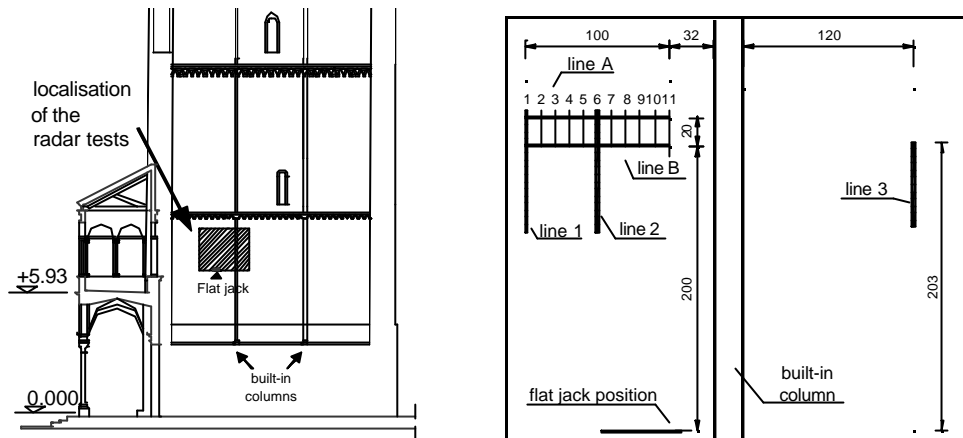
Figure 1: Localisation of the radar tests in the South side of the Tower.

The radar tests were carried out by moving horizontally and vertically a 1.5 GHz antenna. The first examined profiles, concerning scan lines A and B, do not show any evidence. The second group of tests, acquired by vertically scan along lines 1, 2, 3 of Fig. 1, was initially limited to the upper part of the profiles, above line B. The data analysis enhanced a reflection parallel to the wall surface in the lower part of the profile (right hand side in Fig. 2). These deductions are also confirmed by the radar sections extended to the whole vertical scan lines 1 and 3 of Fig. 1; in fact, the sections show a very clear and continuous reflection, due to the media discontinuity. The effect can be explained by the presence of a void or a detachment in the lower part of the acquisition scans. All the acquisitions were, then, repeated scanning down from the line called B in Fig. 1, being evident a concentration of the discontinuity in that area. The group of acquired data, starting from line B (Fig. 3), shows again a coherent reflection just behind the wall surface. It is interesting to note the high energy of this reflection that indicates a sudden change in the dielectric characteristic of the media, as can be expected from a detachment of the external leaf. The supposed detachment is localised below the line B in Fig. 1, and extended in most of the wall area, from line scan 1 to line scan 3.

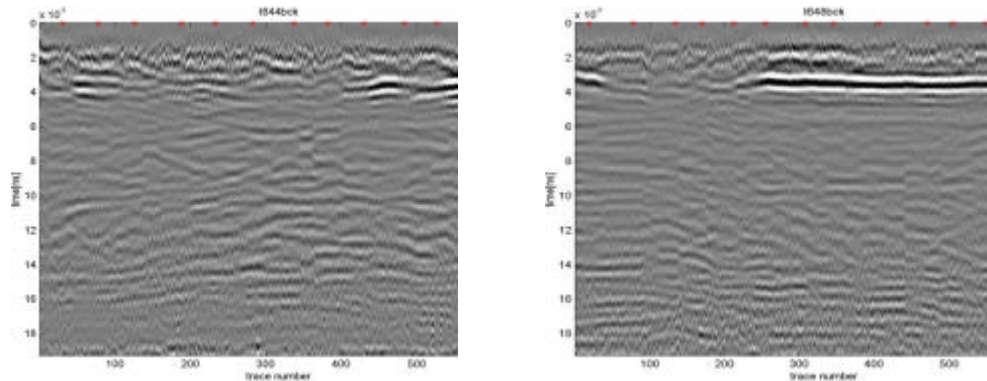
Figure 2: Upper segment of line 2 in Fig. 1. Left to right corresponds to the top to bottom direction. Figure 3: Lower segment of line 1 in Fig. 1. Left to right corresponds to the top to bottom direction.

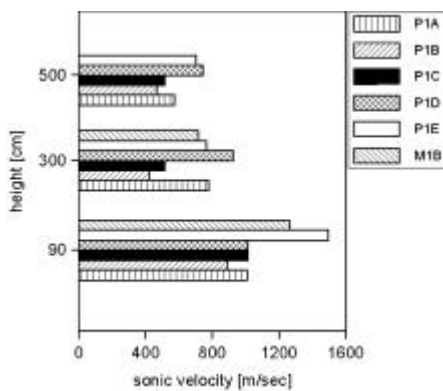
damaged part of the Cathedral. Furthermore the sonic tests were used to control the effect of grout injection used as a possible technique for repair of the damaged masonry. The extensive campaign of sonic tests carried out on the piers shows recursive phenomena. The values of the sonic velocities are decreasing as the height of the piers increases (Fig. 4). The effect can be probably explained by the use of different type of stone, characterised by different sonic tests. In fact, a local calcareous sandstone was used in the lowest part of the pier up to about 1.0 m and travertine, with much lower density and strength, in the highest ones.

Figure 4: Vertical distribution of the sonic velocity measured on piers P1<sub>i</sub> and wall M1B.

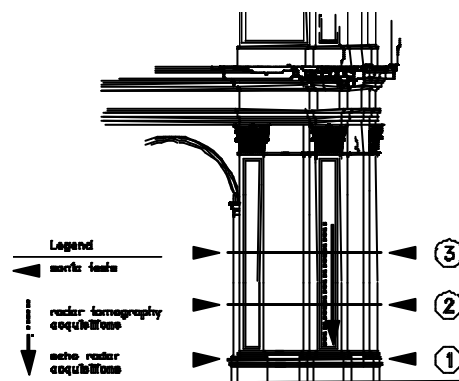
Figure 5: Geometry of the pier P1E and localisation of the sonic tests

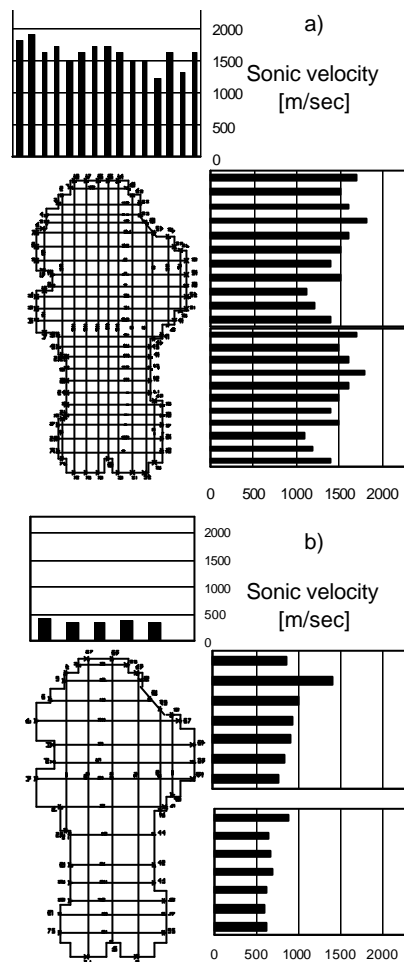
Fig. 6 shows the sonic velocities evaluated on the pier P1E respectively at 0.90 and 5.0 m. The values are clearly decreasing with the height of the pier.

Figure 6a,b: Results of the sonic tests (m/sec) at 0.90 and 5.00 m respectively.

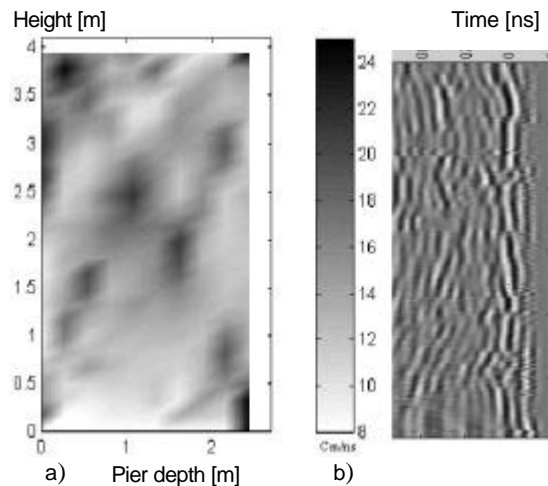
The radar data were acquired for a vertical section imaging. The equipment used was a GSSI SIR 10 with 500 and 900 MHz antennae. The first step of the test was the antenna frequency selection. The 900 MHz antenna did not ensure enough penetration to investigate all the pier section because of the pier dimensions and the high moisture content. Instead, with the 500 MHz antenna the SNR was sufficient to receive the signal even for longer paths; the interpretation was hard only for measures through the lower part of the pier, where the humidity was high. The data were collected both by reflections and tomographic mode. The high moisture level did not allow the study of the pier base, up to about 1.5 m on the floor level. Fig. 7a shows the results of the tomography. The data were processed with a software developed by Valle & Zanzi [8]. In the central part of the pier section high EM velocities are detected. This effect could be explained by the presence of inhomogeneities in the masonry (Fig. 8). In proximity of these areas the sonic tests localised lower quality masonry. Very low EM velocity (about 8 cm/ns) in the lower part of the pier confirms the high moisture content. Fig. 7b shows the echo radar section acquired by vertical continue scans. The complexity of the wall section did not allow a clear identification of the several local anomalies. The radar contribution in this case was limited only to a map the reflections from the external stone leaf (first strong reflection). In the lower part of the profile, the section presents a lower energy return due to high moisture content. In this case the sonic tests allowed an extensive and detailed investigation of the state of conservation of the remaining parts of the Church. The radar tests, instead, were affected by the relevant presence of moisture that imposed to use the 500 MHz antenna and by the general morphology of the rubble masonry, that obstacle the significativity of the tests

Figure 7a,b: Radar tomography and echo-profile on a pier of the Noto Cathedral. The echo-profile scale allows a direct comparison of the results (the time scale of the profile corresponds to about 2 m depth).
