HISTORIC FARMS IN ITALY: SURVEY ON EFFECTS OF LACK OF MAINTENANCE

G. CARDANI¹, C. TEDESCHI¹, L. BINDA¹, G. BARONIO¹
¹ Dep. of Structural Engineering (DIS), Polytechnic of Milan

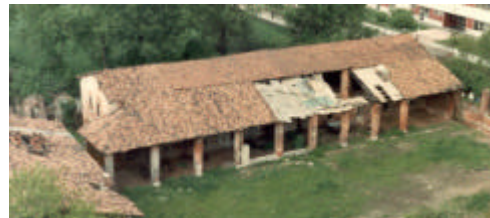
CR represents a typical example of Lombard farmhouses. It shows two courts with different functions and very interesting architectural elements such as the dome vaults of the barns, the barrel vault of the stable and the owner house (16th cent.). Originally “Cassina Ferrarion”, it changed its name in “Cascina Rosa” after it was sold to the Spanish Ordogno da Rosales Family in the years 1637/38. The barns in the main court and the stable were built in 1834-36. During the second world war, the farm was bombed and had serious damages never repaired. Until 1983 the farm was still in use, then the Municipality of Milan became owner and the farm was abandoned to itself (Fig. 1).

Figure 1: "Cascina Rosa": the stable (1989)

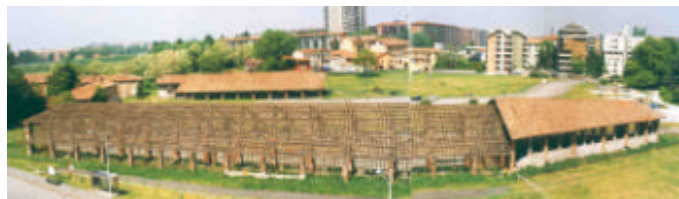
The name of the complex of “Chiesa Rossa farms” is due to the old church S. Maria Rossa (10th cent.) of great historical artistic interest, built on the foundations of a pre-existing Roman sacellum. According to the historic documents, the farm dates back to the 16th century. The stable was built in the second half of the 19th cent. and since this period this complex did not change its configuration (Fig. 2).

Figure 2: "Cascine Chiesa Rossa": the stable (1996)

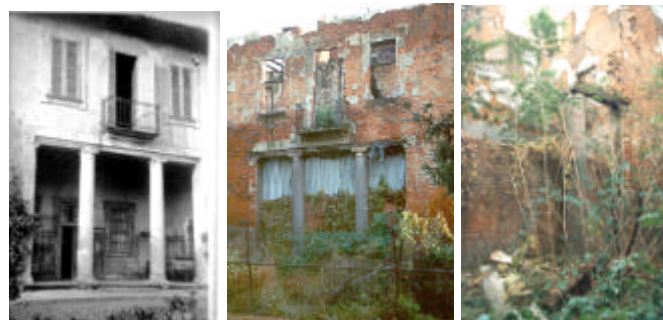
Figure 3: CR: damages evolution of the owner house (1940-'91-'98)

allowed chemical-physical-biological synergisms to cause initially light but then more and more heavy damages and collapse of also large parts (Fig.3). In addition in 1989 the farm was illegally occupied by about 600 emigrants for more than two years. At the end of this occupation the structural elements were found to be seriously damaged; the static conditions of the main building seemed to be compromised. The state of conservation of the CCR was already critical since 1996 when the danger of collapse of the stable roof lead to provisional repair. Finally on March 1999 the restoration started based on a study and diagnosis of the state of damage which lead to an appropriate design.

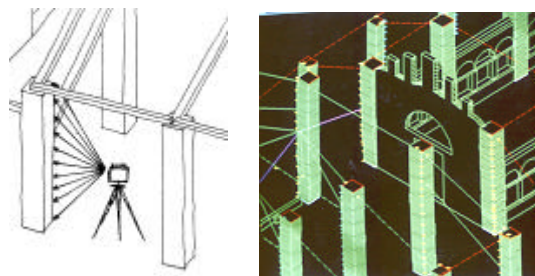
For the CCR stable a more accurate geometrical survey was necessary, realised with electronic devices able to rapidly collect data from the structure and to provide information on the evolution (Fig.4). In fact almost all the columns were out of plumb in different directions due to a lack of connections, as tie beams or floors. Since September 1997 the two columns at the west end of the stable, were out of plumb for 40 cm (Fig.5). As a consequence a displacement of the top beam and of its connected trusses took place (Fig.6). Furthermore due to lack of maintenance the whole timber structure suffered bad decay. The pictures, in order to represent the material decay, acquired for the geometrical survey were also used for the photographic rectification.

Figure 4: CCR: detailed survey of the columns

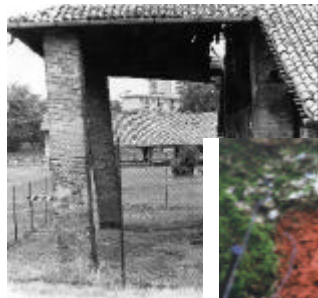
In conclusion, for both farms, foundation settlements and materials decay, above all located in the elements connections, allowed individual movements of the different structural elements (walls, pillars, trusses and ties) [5].

Figure 5: CCR: rigid rotatio

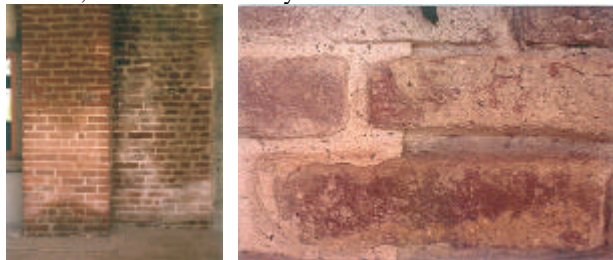
Figure 8: CCR: a) rising damp; b) damage of the repointing

with lime based mortar, carefully chosen. Unfortunately not all the suggestions were fulfilled and moisture source was not completely removed. In figures 8 rising damp is still visible in spots and the repointing mortar is already detached.

The authors supported the designer in the choice of the material and in the intervention techniques for the stable. An intervention aimed to eliminate the high salts and moisture content in the masonries was planned, together with a drainage of the ground, controlling the flow of the meteoric water. No soil and foundations consolidation were planned, because compatible with the project. More attention was paid in the strengthening of the structures, reinforcing the connections among the roof, floor and masonry elements. Particular care was proposed for the conservation of the trusses. Cleaning was proposed to be made only through brushing, avoiding sandblasting. The missing part had to be substituted using bricks with the same physical and mechanical characteristics as the old ones. Decayed mortar joints had to be cut out and repointed
