THE BISHOP PALACE IN DUBROVNIK: STRUCTURAL ANALYSES AND PROPOSAL OF REMEDIAL MEASURES

A. BONCI¹, A. VISKOVIC²

SUMMARY

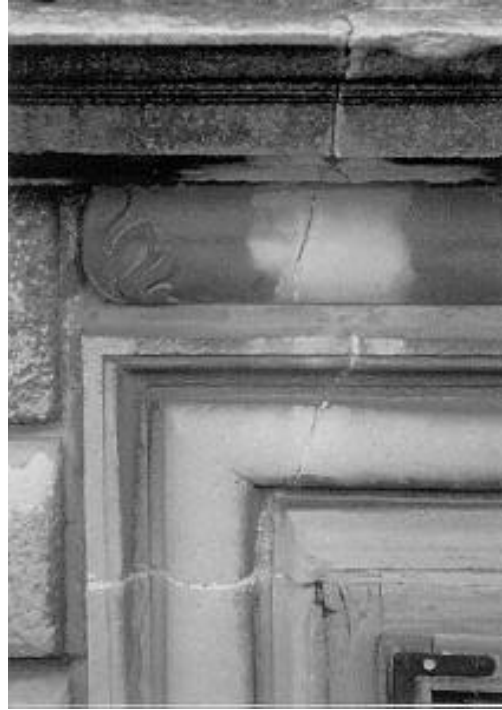
Fig. 2 : A cornice under the balustrade

good values of resistance, but it was also noticed that the heterogeneity of the masonry due to frequent modifications, and diffuse damage caused by the seismic action, contributed to weaken the structure in large areas. Cracks are now visible near most of the doors and lintels, and on the East Façade. A particular problem was detected on the North façade (Fig. 1), where parapet walls, built in the 18th century, are not actually connected to the structure and do not co-work with the rest of the wall, weakening the façade at this level. Cracks on the cornices under the balustrade of the second storey are now visible under almost all of the windows (Fig. 2). In the preliminary project elaborated by University of Zagreb several interventions were proposed, not only to strengthen the structure, but also to permit the new activities that are going to be performed in the building and to recover its original aspect. Thus, in the preliminary project, the demolition of the parapet walls of the balustrade of the first storey of the North façade was proposed, in order to return the façade to its original 17th century aspect.

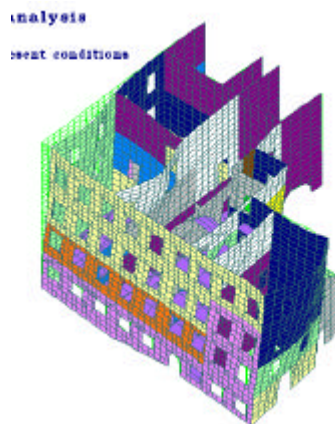
Fig. 5 : 1st Mode (Present conditions)

Firstly, response spectrum analyses were performed, that showed that the first mode of the building was in the East-West direction (Fig. 5), involving the North Façade in its own plane, and producing relevant tensile stress (Fig. 6). As significant interventions had been proposed on this wall, already damaged by earthquakes, a local model of the North Façade, with an increased density of the F.E. mesh, was arranged to study this area in detail.

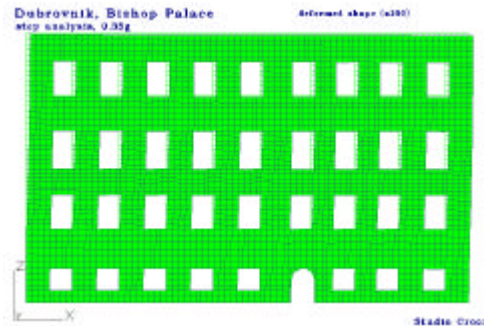
Fig. 7

A first local model was performed supposing that the parapet walls of the second storey were actually co-working with the rest of the structure, as it could be obtained strengthening the zone behind the balustrade of the French windows. The results show that in this case the façade has no problems respect to horizontal actions: at the value of 0.35g, corresponding to $0.35 \cdot 0.85 = 0.3g$ on the whole structure, the façade is still in the elastic range, and no elements are broken (fig. 7).

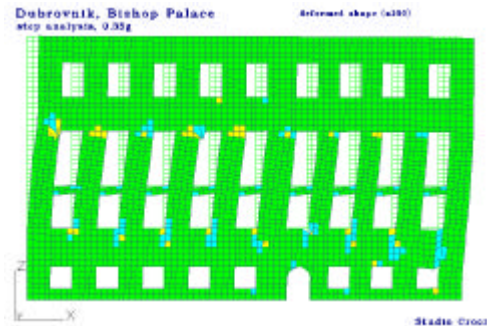
Fig. 8

The analyses show that the absence of co-working parapet walls at the second storey level has important consequences on the structural behaviour of the façade, that can be summarised as follows (Fig. 8):

- ?? The façade has a weak zone under the balustrade of the second floor.
- ?? A “shear type behaviour” of the portions over the ground floor is clearly visible from the deformed shape, due to the reduced stiffness of the walls between the windows of the second and third storey.
- ?? First cracks appear for $a_g = 0.175g$ (corresponding to $0.175 \cdot 0.85 = 0.15g$ on the whole structure), and at $a_g = 0.40g$ (corresponding to $0.40 \cdot 0.85 = 0.34g$) the portion over the first floor collapses

As first cracks appear in the zone under the windows of the second storey, it is confirmed that this zone of the building is weak, as it was suggested by the survey of the damage.

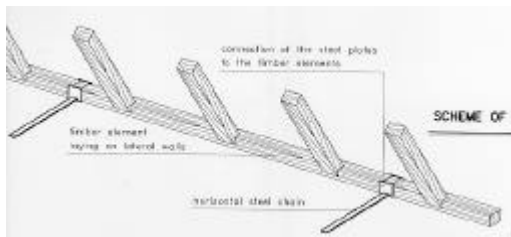
Apart from the solutions mentioned above, other interventions were proposed in order to improve the structural behaviour of the Bishop Palace. Among them horizontal chains were proposed at the floors and roof level, in order both to contrast the thrust developed by the arch effect produced by seismic actions perpendicular to the plane of the wall (Fig. 10), and to prevent the detachment of the façade. Horizontal chains were showed to be indispensable also for the timber structure of the roof (Fig. 11), now thrusting on the walls, due to the absence of chains at the level of the base of the inclined timber elements (Fig. 12).

Fig. 11 : The arch effect on masonry walls
