SALVAGING THE CAPILLA DE LAS ÁNIMAS IN MEXICO CITY

E. OVANDO-SHELLEY¹, E. SANTOYO²

¹Instituto de Ingeniería, UNAM, Mexico City, ²TGC Geotecnia, Mexico City

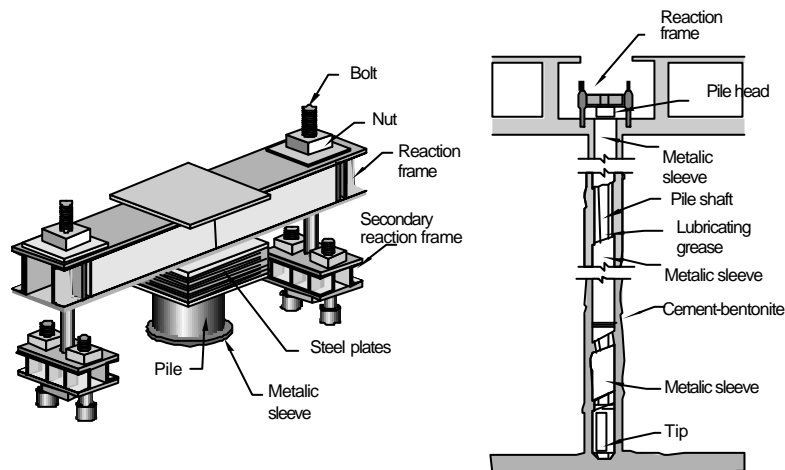
The Chapel was underpinned with ten point bearing piles provided with control mechanisms for correcting tilts and differential settlements. The piles were driven down to the first hard layer and were provided with external deformable sleeves to avoid the effects of down drag forces on the shafts produced by regional subsidence and by subsidence induced by underexcavation in the Cathedral. Reinforced concrete beams were required to allow the installation of the piles. A plan showing the distribution of piles is also given in Figure 1; details of the control devices and the friction sleeve are illustrated in Figure 2. The underpinning project was carried out in the first half of 1991.

Figure 2 : Pile with anti-friction sleeve and control device in its head

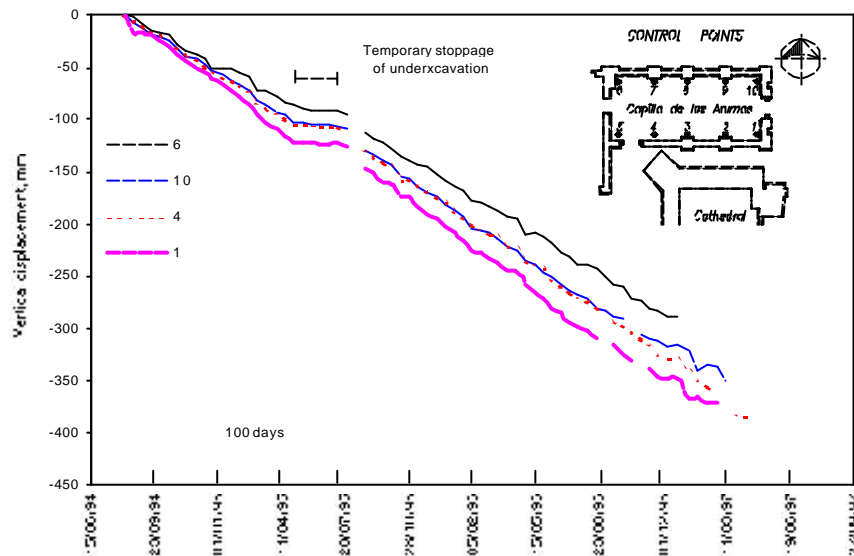
There are no instrumental records of the Chapel's behaviour before August 1994, i.e. one year after underexcavation began in the Metropolitan Cathedral. However, it was apparent that fissures and cracks along its southern wall were growing continually. Plumb lines installed after that date showed that the chapel tilted 0.84 % towards its south west corner between August, 1994, and September, 1995. Convergence measurements with extensometers also showed that the lateral walls were opening and that their upper parts were tilting at a higher rate. Finally, topographical levellings at the level of the new concrete foundation beams indicated that the south wall settled at a higher rate than the wall in the north side, as seen in Figure 3. Settlement rates along the northern wall averaged 13 cm/year whilst the average rate along the south side was 15.7 cm/year. Maximum settlement rates were observed at the south east corner. Underexcavation in the Cathedral stopped temporarily between 17 April and 14 July, 1995, and differential settlement rates in the Chapel became almost negligible over this period. However, when underexcavation started again, settlement rates rose slightly and equalled 13.7 and 16 cm/year along the north and south walls, respectively.

Figure 3 Evolution of differential settlements before modifying foundation

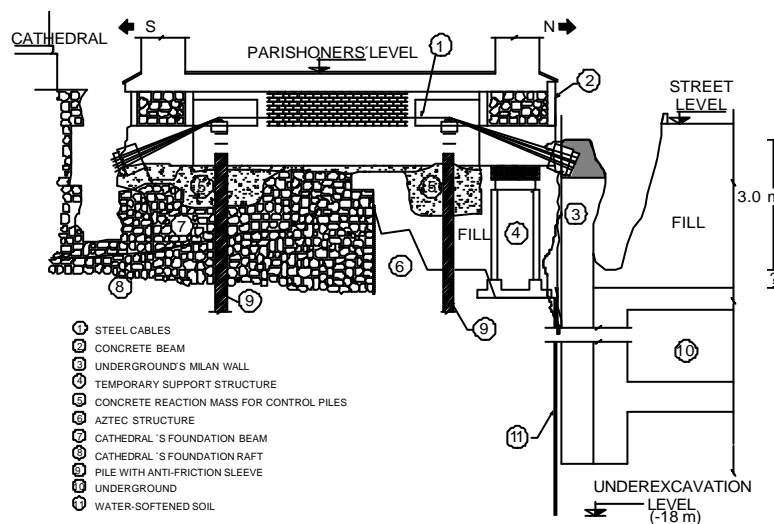
Figure 4 : Typical cross section below the Capilla de las Ánimas

Isolation of the Chapel was achieved by means of a line of injection wells along the north wall. Water injected through these wells moistened the clay below the north wall thus reducing its capacity for transmitting shear stresses thus allowing the Chapel and the underground tunnel to move independently. The wells were drilled at one-metre intervals down to the depth at which the Cathedral was being underexcavated in that zone (18 m). The sides of the retrofitted foundation beams were also covered with two layers of lubricated polystyrene plaques, placed along the north, east and west walls. A schematic view of the elements described here is given in Figure 4.

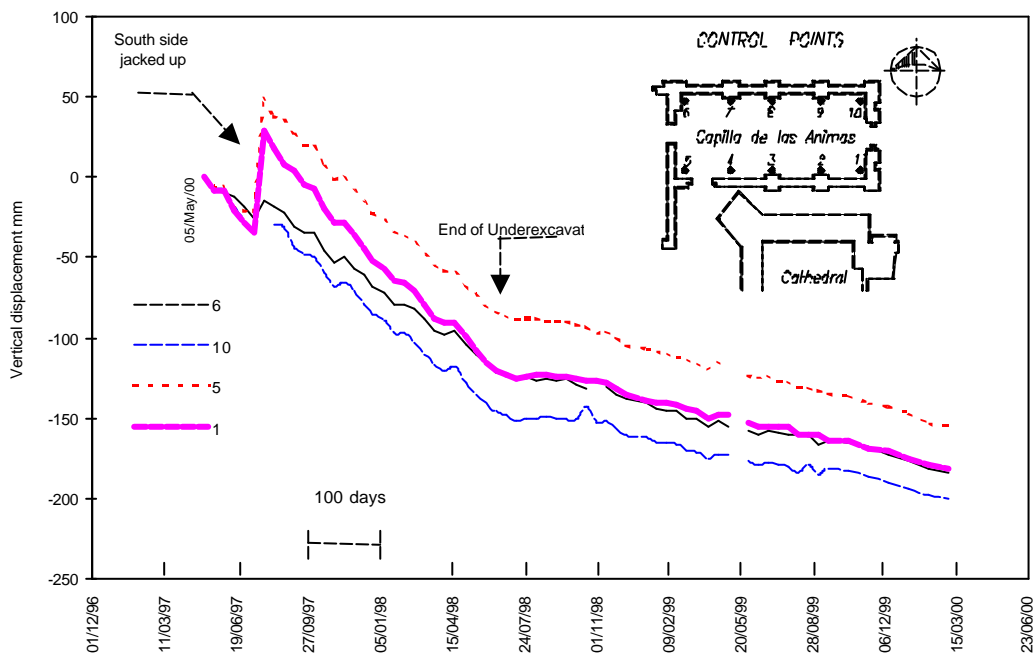
The graph in Figure 5 shows the evolution of differential settlements at the level of the concrete foundation beams, from 5 May, 1997 to 2 May, 2000. The sharp change in the levels of the control points near the south wall in early May 1997, is due to the jacking of the Chapel. Thereafter, when the piles were attached to the structure, settlements were mainly due to consolidation of the second clay formation, lying below the first hard layer. Settlement rates have been nearly equal after November 1998. The average value is 3.5 cm/year, roughly 50% of the total regional subsidence rate in that zone. This value closely matches the historical rate of settlement deduced from deep benchmark measurements [3].

The thickness and the compressibility of the second clay formation under the Chapel are not uniform and additional differential settlements due to further consolidation of the second clay formation produced by pore pressure reductions brought about by deep well pumping will occur in the future. Whenever necessary, they will be kept under check releveling the Chapel by operating selectively the piles' control devices.

Figure 5: Differential settlements after jacking-up the south side

Upon the conclusion of the remedial works, the Chapel was jacked along the south wall in order to reduce partially its inclination. Using the temporary steel structure as support, hydraulic jacks were placed under the south wall, which was raised gradually in small increments. As a result, the south wall rose a total of 9 cm and its inclination towards the Southeast reduced an average 1.08 %.
