The unusual dome of the Cappella Emiliana on the Island of San Michele in the Venice Lagoon

Alberto Lionello¹, Claudio Menichelli²,

Abstract The Emiliana chapel, built between 1528 and 1543, is hexagonal in shape and is surmounted by a hemispherical dome. The most distinctive feature of the construction is its complex roofing system. This consists of two hemispherical caps connected by a central pillar. The inner cap is made of brick masonry and the outer dome of blocks of Istrian stone, arranged in horizontal courses. The masonry central pillar is connected to the outer shell by iron tie-rods.

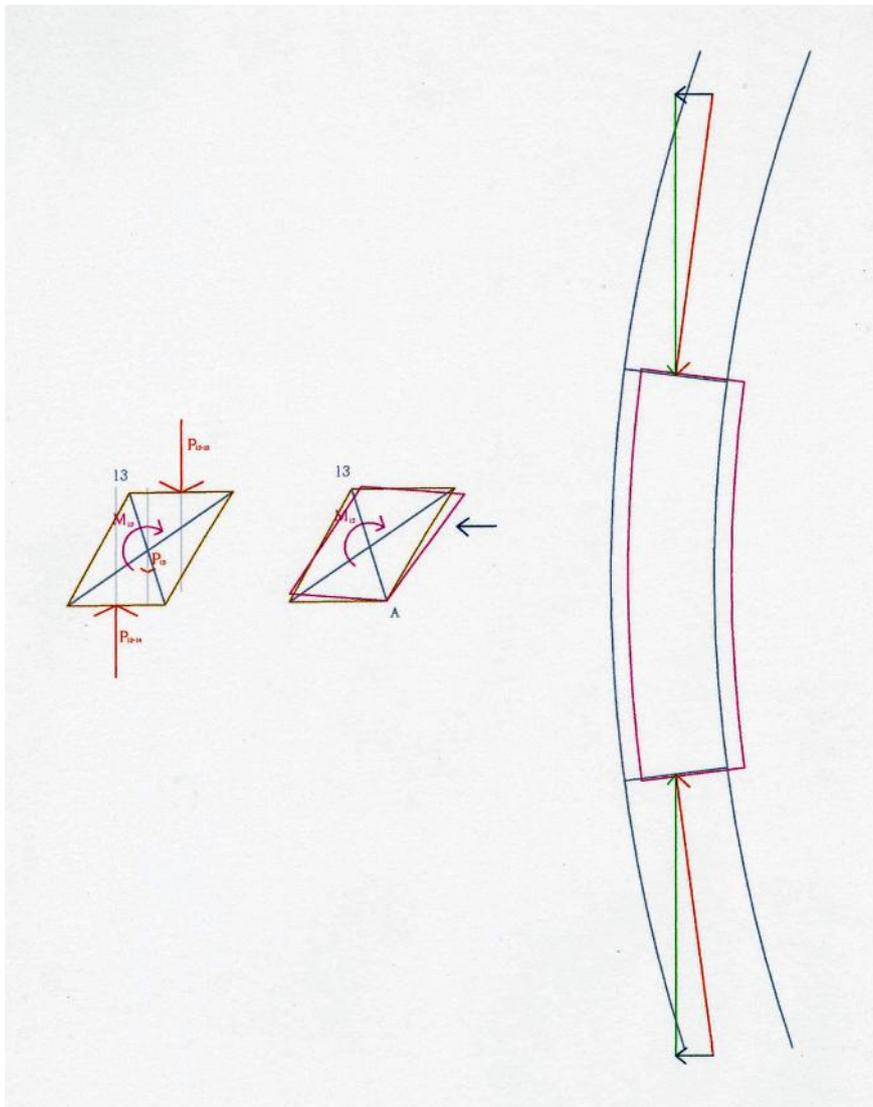
Fig. 7 - Block no. 13 (Drawing A. Lionello).

This is opposed by an equal force, increased by the weight of the element itself, applied in its geometric centre of mass. Equilibrium is guaranteed with respect to the vertical forces but the different point of application of the forces generates a moment that encourages the block to rotate around point A. The rotational force is opposed by the equal phenomenon generated in the neighbouring blocks and which, in the case of symmetrical loads, prevents the deformation of the circular crown. Opposing forces develop if the vertical joints are able to transmit forces of a magnitude which is greater than that required to prevent the rotation. It is therefore necessary for the side faces of the blocks to be coplanar and close-fitting if they are to transmit the important stresses. Any further deformation or symmetrical stress will stabilize the structure. Perhaps also in order to support the heavy stone pinnacle weighing 3.2 tonnes a central pillar resting on the inner cap was inserted during the original construction work.

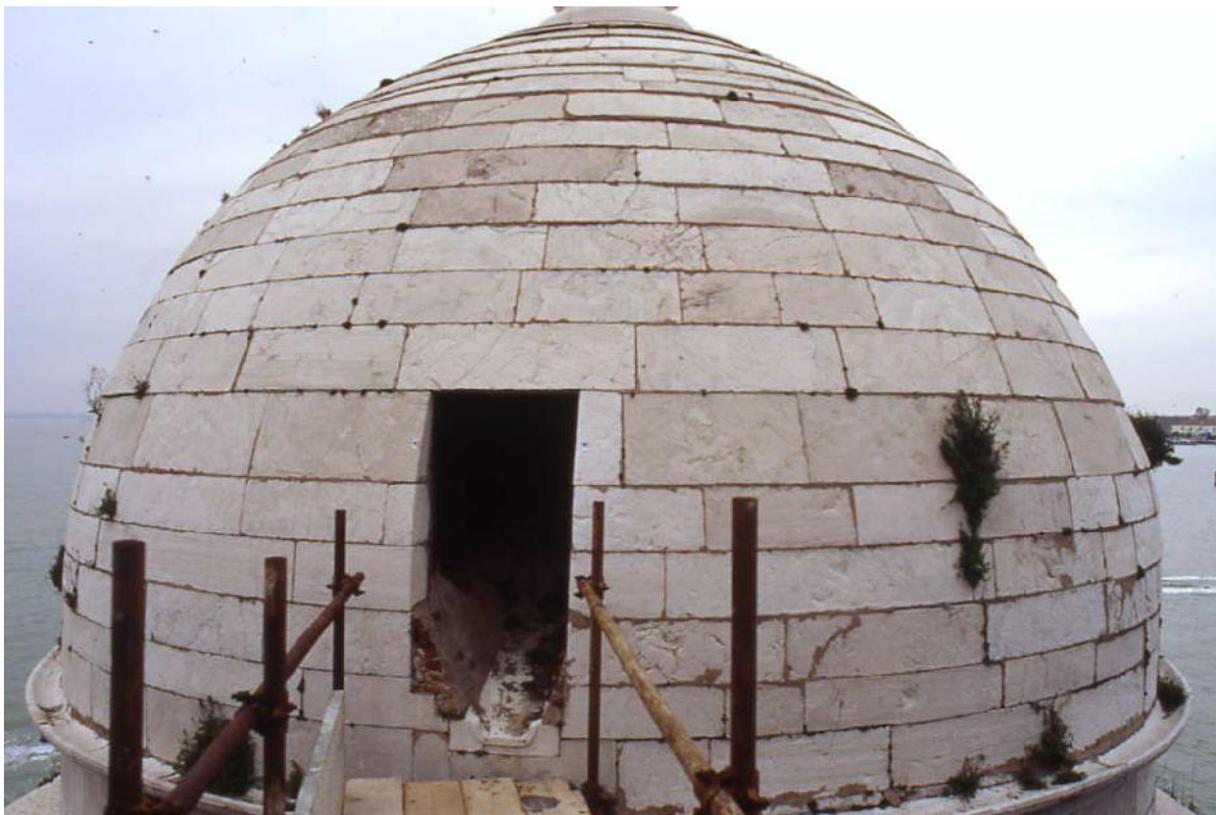
Fig. 8 – The dome before restoration. At the top, the movement of the blocks caused by the rusting of metal cramps (p. C. Menichelli 1999).

The prime cause of rainwater leakages was the rusting and consequent swelling of the iron cramps holding the stone blocks together; as a result, the blocks tended to lift and open the horizontal joints between the courses, a worrying phenomenon that would have worsened considerably over time if neglected. The top seven rings of the dome were therefore dismantled, the iron cramps were replaced with elements of identical shape but made of stainless steel (AISI 316) and the blocks were relaid in their original positions.

Work to rebuild the cap also involved remaking the vertical mortar joints in such a way as to guarantee close adhesion between the blocks, the continuity of the rings and the establishment of the tensions needed to stop the stone blocks rotating towards the interior. To ensure greater clarity in the structural roles of the elements constituting the dome it was decided to improve the interaction between some parts and the independence of others by calibrating the mechanical characteristics of the mortars used. Mortars with greater elastic modules and resistance were employed for the horizontal and vertical joints between the stone blocks while binders with lower mechanical properties were used to remake the joints between the cap and the brick ribs. The tie-rod systems were tested; the lower set was found to be no longer efficient and was replaced with identical elements in AISI 316 stainless steel; the upper set was restored and reinstalled.

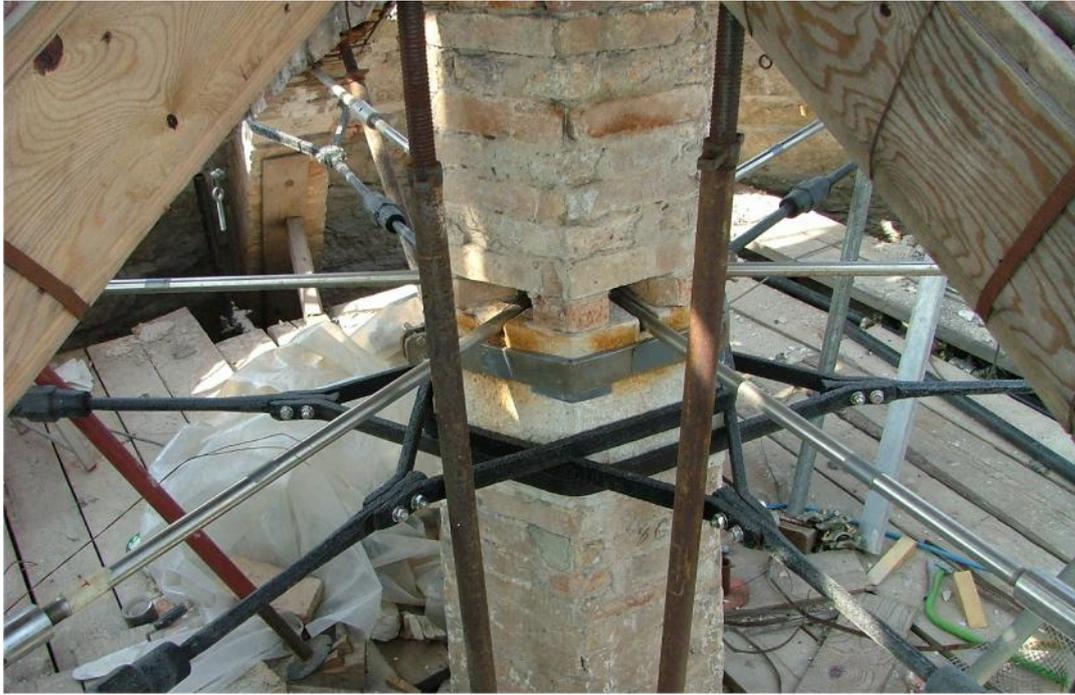
by the ribs gives positive results. The sonic tests carried out on the two sets of metal tie-rods inserted into the upper part of the dome gave insignificant results and therefore confirmed that, given their position, the tie-rods only perform the function of stabilizers.

Fig. 9 – The tie-rods after renovation/replacement (p. C. Menichelli 2004).

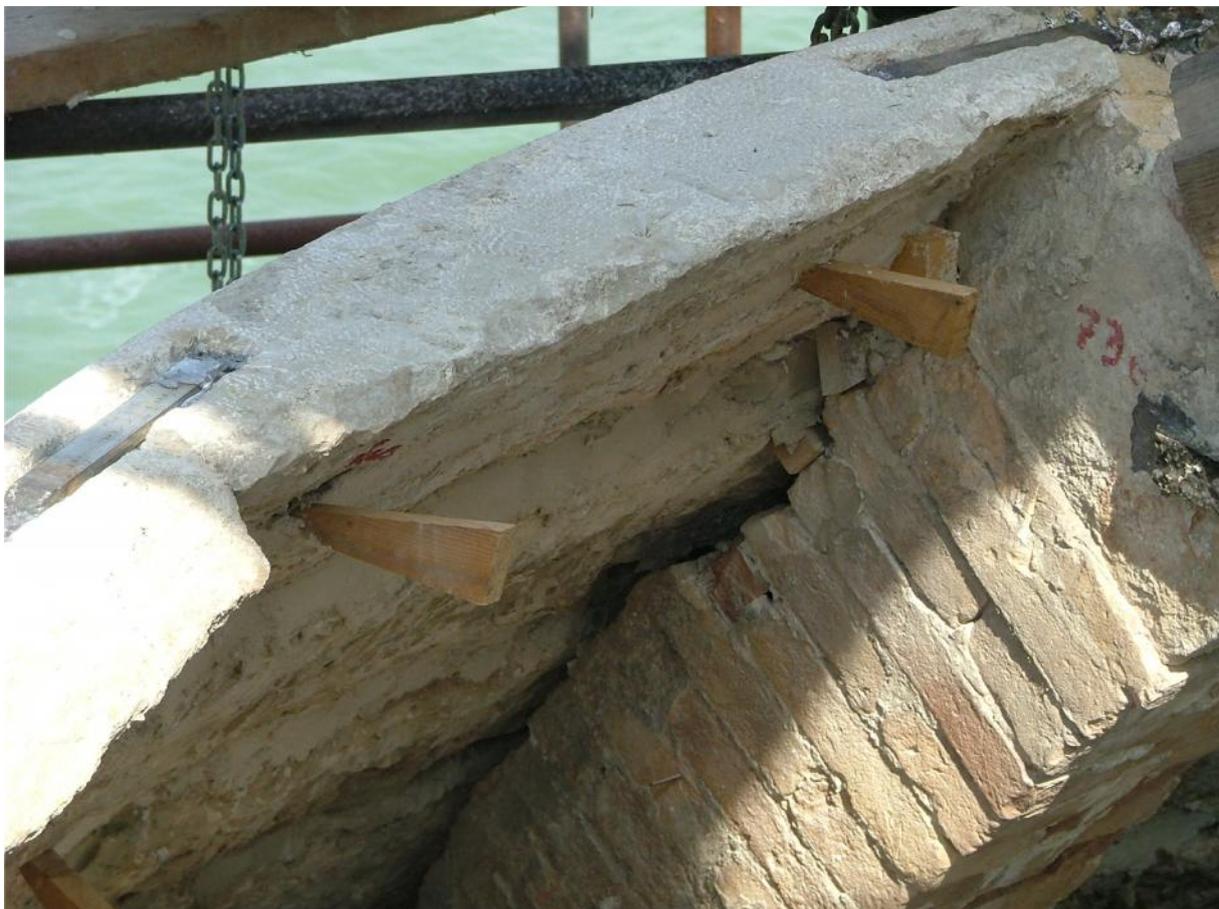
Special attention was paid to the interface between the outer cap and the ribs. In previous operations these spaces had been filled with chips of brick and mortar. Any stress or deformation was absorbed in part by the *tholos* structure and partly by the structure of webs and ribs, depending on their relative rigidity. The two structures did not have compatible deformations, however, and when the structural component of the ribs came into play it introduced deformations in the circular rings of the *tholos*, and jeopardized their stability. It was therefore decided that the consolidation project should establish a hierarchy for the order in which the structures came into play; first the dome must function as a *tholos*, as in the original conception, and only later, if this proved structurally inadequate should the ribs come into play and the segments of the cap function as webs. This principle was put into practice by filling the joints between the dome and the ribs, just to the edge, with relatively elastic mortar; this enables the stresses between the two structures to be transmitted only in the presence of serious deformations caused by the loss of efficiency of the *tholos*.

Fig. 11 – The dome completely separated from the ribs before the gap was filled with low elastic module mortar (p. C. Menichelli 2004).
