EARLY TWENTIETH CENTURY TRANSITIONAL FACADES IN THE UNITED STATES: COMMON MALADIES

C.L. SEARLS¹, M.B. BRONSKI²

SUMMARY

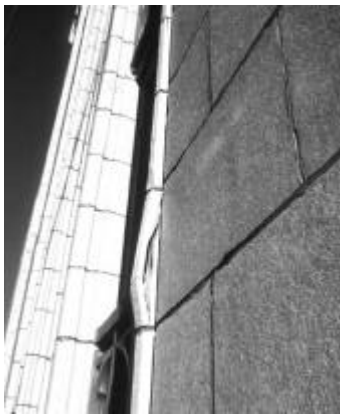
Figure 2: Buckling of terra cotta

If the outer wythe masonry expands but is restrained by the structure, it will eventually crack, spall, or buckle under the accumulated stresses. For example, in high-rise buildings clad with terra cotta, high stresses can accumulate in columns, causing buckling of the terra cotta masonry (Figure 2). At columns where the outer wythe of masonry is vertically continuous for the full height of the building, thermal and moisture-related expansion accumulates over the full building height (these buildings are often between six and thirty stories tall). If the structural frame is reinforced concrete, the columns will shorten over time,

exacerbating the problem. Strain relief or flat-jack testing can be used to estimate the level of stress in the terra cotta. In situations where the terra cotta stresses are not excessive, repair often involves cutting expansion joints between the terra cotta block and the underside of steel shelf angles to relieve the stress, installing a compressible sealant joint to accommodate future movement without accumulating stresses, and then repairing the fractures in each terra cotta block.

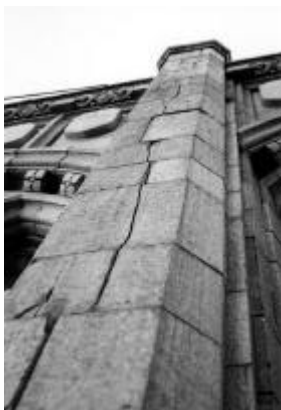
found close to the surface of the facade such as lintels and shelf angles. As steel corrodes, it expands, exerting tremendous pressure on the surrounding masonry and causing cracking, spalling, and displacement (Figure 4). One of the most serious corrosion problems occurs when the corrosion reaches the structural steel frame. Often, an early sign is the appearance of bulges or vertical cracks in the masonry facade over the columns, particularly at the corners.

Figure 4: Cracks in terra cotta due to corrosion of underlying steel column.

While some relatively new methods of corrosion protection, such as cathodic protection and corrosion inhibitors, are being implemented on steel-framed transitional facades, these methods seek only to prevent further corrosion and *not* to remedy existing corrosion. To remediate a sectional loss of embedded steel members, the common method of repair is to expose the deteriorated member by removing masonry, supplement or replace the steel member, and reinstall the masonry. During structural repair, traditional techniques (cleaning, painting, and flashing) or newer methods (cathodic protection, corrosion inhibitors) can provide corrosion protection for the steel.
