MEASURES TO STRENGTHEN THE REMAINS OF THE *DOMUS TIBERII* IN ROME

A. CARRIERO, F. SABBADINI

Civil Engineer, CISTeC - University of Rome "La Sapienza", Italy

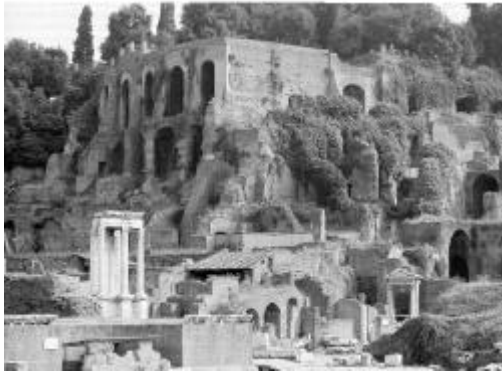
Figure 1

Today the ruins of Hadrian's substructures, overlooking the Forum, consist of a range of rooms, with wall 15 meters high, closed by barrel vault (Fig. 1). These structures artificially extended

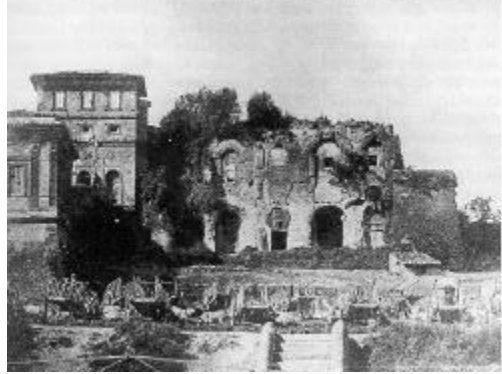
Figure 2

The ruins of the Domus were therefore abandoned or used to agricultural purpose and, finally, after the half of the XVI century, included in the Garden established by the Farnese family on the Palatine hill. At the end of the 19th century, before the excavation works, the remains of the Hadrian's substructures, overlooking the Forum, were partially covered with earth, the arcades closed by walls and lacking in some portions of the vaults and internal walls and with large gaps in the original brick face (Fig. 2).

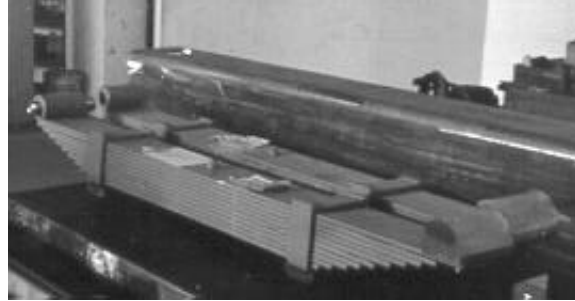
Figure 8

In accord with the forces required in the systems of tie-bars, two different elastic restraints have been designed. The three levels, tying the front wall, employ a device equipped with a calibrated spring leaf (Fig. 8). For each pair of ties, the bars are fixed to the ends of spring, which is inserted in a crossbeam leaning on the inside wall. Instead the tie-bars of the buttresses are equipped by a stack of cup springs fitted in a cylindrical device, that has been inserted in the hole through passes the tie-bar (Fig. 9).

These devices, as well as to apply a constant force, allow to minimize the effect of the different thermal expansion between stainless steel and masonry. In the longest bar (about 16m) the different elongation reaches $\pm 3.15\text{mm}$, while the tension in tie fluctuate in a range ($\pm 10\%$), that is bearable by the structure.
