# THE STRUCTURAL BEHAVIOUR OF THE PYRAMID OF CHEPHREN

G. CROCI<sup>1</sup>, M. BIRITOGNOLO<sup>2</sup>

## 1. INTRODUCTION

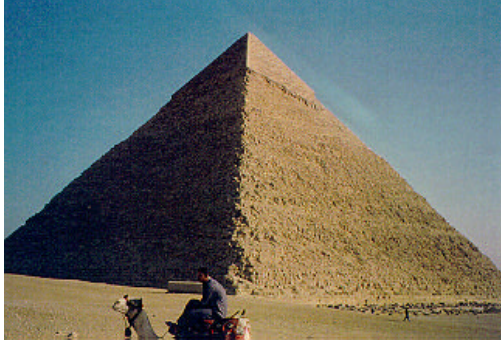
Fig. 1

The Pyramid (Fig. 1) has been built by the Pharaoh Chephren, who was the fourth king of the IV Dynasty (2620-2480 bc.), during the so-called "Old Kingdom". Nearby the Pyramid, Chephren erected also its valley building and mortuary temple, connected with the Sphinx that is thought to be a portrait of the King. The Pyramid has a square basis oriented in such a way to face with each one of its sides one the cardinal points; its original height was of 143.55 mt., and therefore about 3 meters lower than the Great Pyramid (Cheope's Pyramid). The present height of the monument is about 136.39 mt., being missing the very top portion including the capstone. Owing to its position on somewhat higher ground, Chephren's Pyramid creates the illusion of being taller than the Great Pyramid. Formerly each side of the monument measured 215.71 mt.; if faces slope at an angle of  $52^{\circ}20'$  as so they rise more steeply than the faces of the Great Pyramid that is a little higher but has the sides considerably larger.

For the construction of the body of the Second Pyramid, blocks of limestone and sandstone were used. For the casing instead, the stone employed were Tura limestone for the upper remnant, and red granite for the lower. Also the capstone, which has now disappeared, may also have been made of granite.

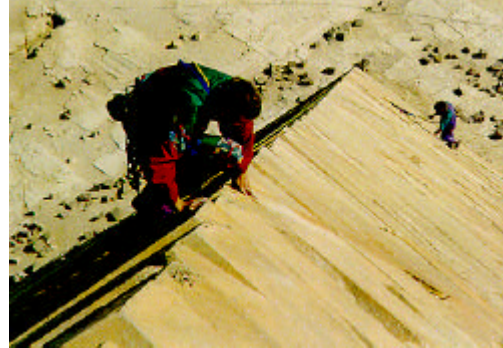
Fig. 2

After two years of researches of documents and studies on the seismic behaviour of the Pyramid, between 17 and 20 November 1994 a climbing and a close survey of the Chephren Pyramid have been carried out accordingly with the relevant Working Plan (Fig. 2). The overall operation has also included the shooting of a tape recorded TV Scientific Documentary, illustrating the different phases of the operation.

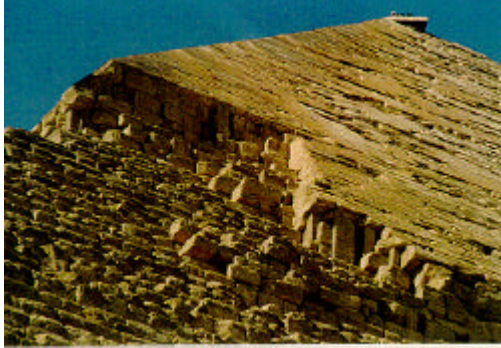
Fig. 4

The reason of this configuration will be explained below. The casing blocks have a horizontal development, and their joints show an exceptional precision of working of the stone faces and contain very thin layers of mortar. The dimensions of the blocks are variable in length and height, as described in the previous paragraph and shown in Fig. 4.

The stone blocks were put away starting from the actual lower border of the casing, as shown by the verticality of the border surface that have been cut using chisels (Fig. 4) After having removed the first rows of blocks it has been very easy to proceed to the dismantling of the other strata from the top to the bottom, not only of the casing but also of the rear elements. The cornice that appears now at the bottom of the medium zone is in reality nothing else that the last level of the utilised quarry.

The ascent of the Pyramid has allowed to immediately answering to the first two questions: The main destruction of the Pyramid is due to having used the monument as a quarry. However, while in the earliest times this destruction has been brutal, without any organisation (lower zone), in the Middle Age the removal of the blocks has followed a precise rational program (middle zone), cutting a row of stones immediately below the present survived casing and realising some little walls and masonry pillars to sustain it (Fig. 4).

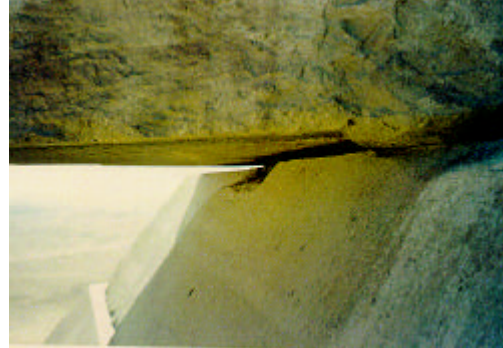
Fig. 5

The dynamic analysis in time-history gave the acceleration in relation to specific points; in particular the values reached at the points where the slippage between some blocks surveyed was detected. The maximum acceleration reaches values of  $(0.6\text{?}0.75)$  g, showing an amplification with respect to the ground of about 2?2.5.

On the basis of the above results, a local analysis was carried out to check whether the shear forces exceeded the friction strength and consequentially, sliding between blocks could be produced. The results of the analysis revealed that locally, and particularly in the upper zone where the vertical loads are lower, the shear forces, combined with a reduction of the vertical stresses during the earthquake, may exceed the friction strength causing permanent displacements (Fig. 5).

The sliding related to the various earthquakes may have produced, therefore, the observed permanent displacements; these, magnified by the effects of subsequent earthquakes, may well have led to unstable situations and ultimately to the falling of some upper blocks.

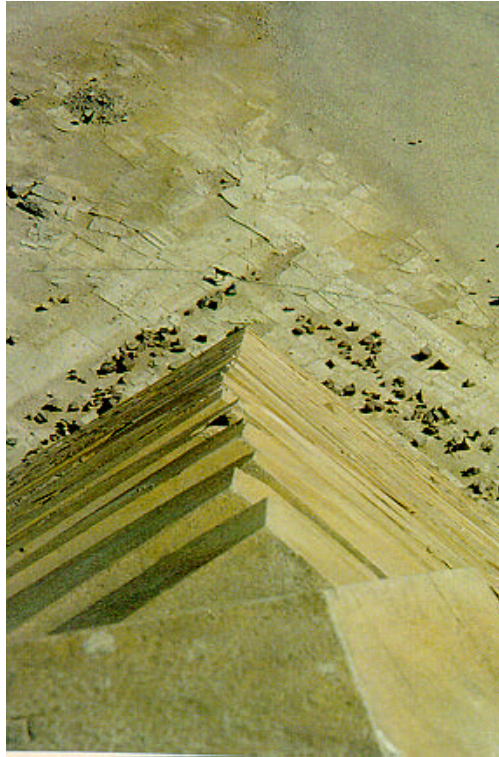
Fig. 6 : Relative movements of the blocks in the corner of the Pyramid

The interpretation of the alternate displacements of the blocks that have been surveyed in the upper part of the corners is more complex (Fig. 6). This phenomenon can be explained by integrating the mathematical results with qualitative considerations, which regard the geometry of the blocks, the horizontal contact surface between them and the position of the applied loads (Fig. 7).

These phenomena contributed to the development, in each corner block, of an eccentricity of the centre of rotation with respect to the barycentre, in which seismic forces were applied creating twisting effects which have caused the observed alternate displacement (Fig. 6).
