ARCHITECTURAL HERITAGE AT RISK: A PROPOSAL FOR THE SITE OF PETRA

G. CROCI

3. THE SITE OF PETRA

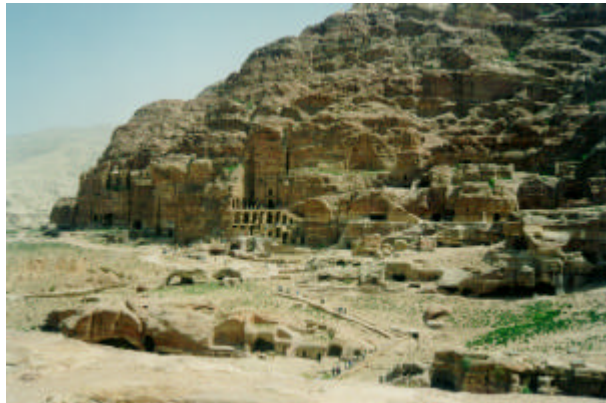
Fig. 2

The site of Petra, besides the risks due to uncontrolled tourism, suffers damage and large processes of decay of the natural stone, which represents the bearing structure of the carved temples (Fig. 2).

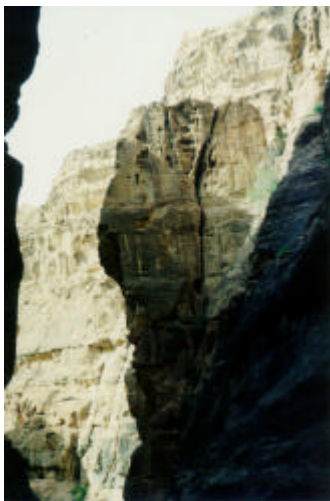
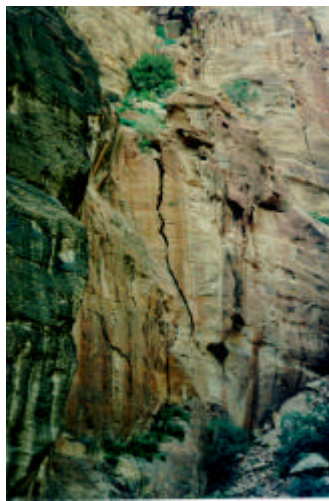
Beginning from the Siq which represents the main gate to Petra, immediately large cracked rocks dangerously hanging on the narrow passage appear (Figures 3, 4); the continuity of the Structure is interrupted and separate blocks remain in precarious equilibrium with serious risks for the tourists below.

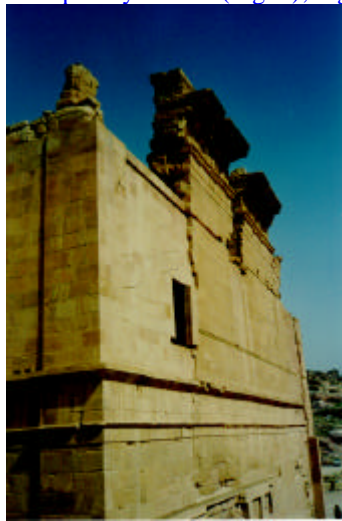
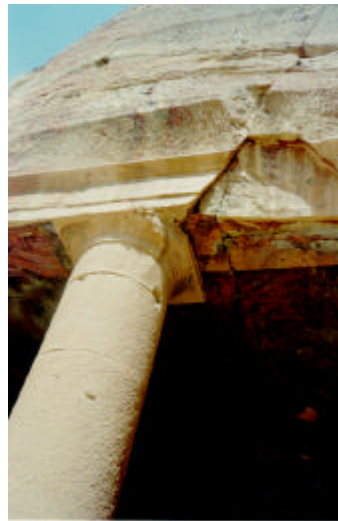
The Qasr al Bint temple, one of the most important of the site, was heavy damaged and partly destroyed by earthquakes; the survived structures are in a very dangerous situation (Figs 6, 7). In the Urn Tomb the rock on the left side of the façade is affected by large cracks (Fig. 8); the situation appears to be potentially very dangerous because the rock structure is there thin and deteriorated, as also clearly results looking at the external side of the structure. Decay phenomena affect the main columns of the façade as well, which present large cracks and whose base has been completely eroded (Fig. 9); urgent measures have to be undertaken here too.

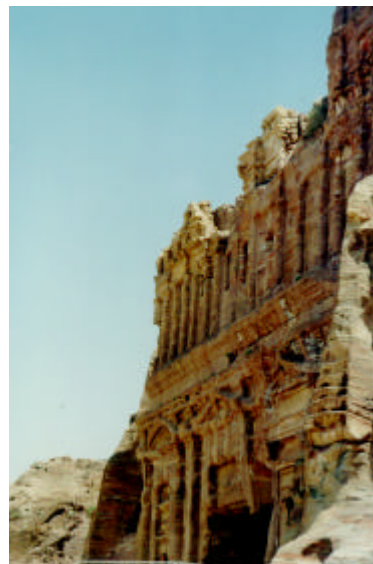
Fig. 9

In the Palace Tomb, the situation is dramatic; a huge portion of the façade is becoming detached from the body of the rock (Fig. 9). The area has been closed to the public. Consolidation works and the anchorage of the structure are urgent.

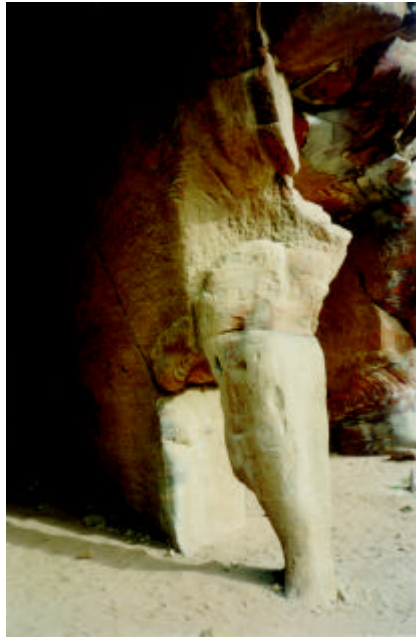
Fig. 10

All the temples in different ways suffer from stability problems, mainly concentrated on the pillars or walls, which often are affected by vertical or inclined cracks that, when completely extended into the mass, may become very dangerous (Fig. 10). The progressive erosion produced by wind and rain has dangerously reduced the section of the bearing structures (Figures 11, 12).

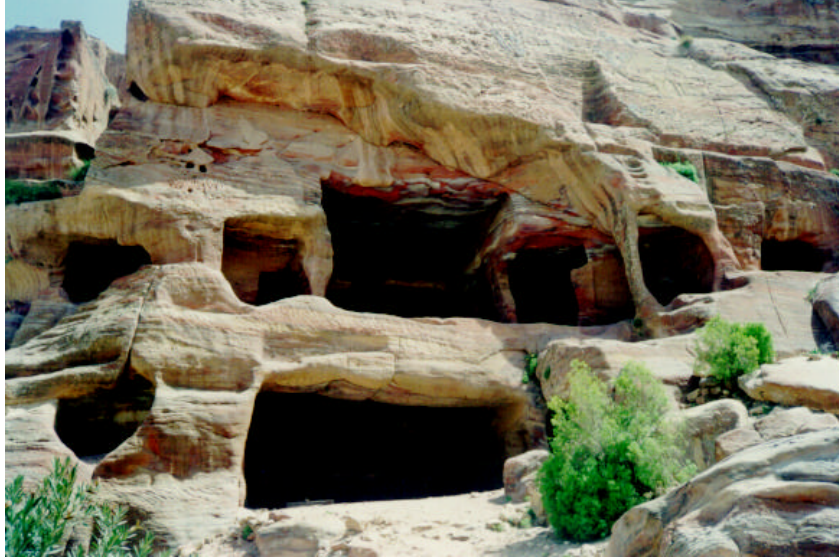
Fig. 13

The ceilings are often made of slabs made up of harder strata separated by thin softer horizontal ground layers; when the dimension of the slab is too large, or a pillar collapses, the stability is at risk and a mechanism of progressive detachment and collapse of the layers begins (Fig. 13).

The resistance of the ceiling is also influenced by the global movements of the rock: those movements produces vertical cracks that interrupt the continuity of the slabs; in addition the percolation of the rain, associated with the wind, progressively erodes the materials.

If measures are not urgently taken this incomparable Cultural Heritage will be lost. Interventions, however can't be carried out random, but it is firstly necessary to complete the general survey and risk analysis that we have began in occasion of the UNESCO mission of May 1999.
