MATERIAL CONSERVATION AND LEGIBILITY: THE DOUBLE AIM OF THE ARCHAEOLOGICAL STRUCTURAL INTERVENTION.

G. MANIERI ELIA
University 'La Sapienza' of Rome

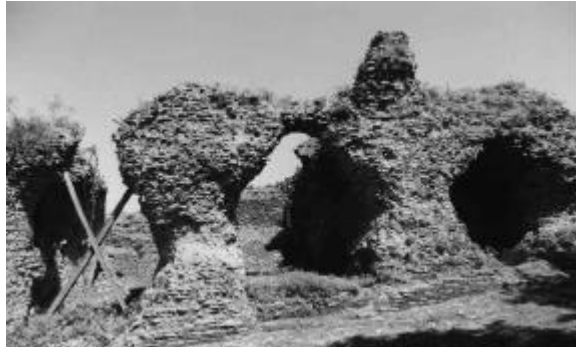
The Severiano Amphitheatre of Albano is a large elliptical structure built in the first decades of the III c. A.D. by the Second Partic Legion. It was partially excavated directly from the rock and built with layered stone arches which probably would have reached a height of 22 metres. Before being restored little remained of the original structure and it was in a poor and unstable condition. The high level of degradation, especially in the crown of some vaults,

Figure1: The amphitheatre before the restoration.

resulted in many walls remaining unsupported. This meant that they risked collapsing in the event of seismic activity. Moreover there were some part of concrete (*opus*) not contrasted by the lateral forces of the vaults. To stabilise these ruins two solutions existed. The first of these was to build a steel structure to link the different parts, the alternative was to reintegrate the masonry arches. We opted for the second solution as it allowed us to restore legibility to the archaeological text. As a result, it is easier for visitors to understand the architectonic significance of the remaining structures.

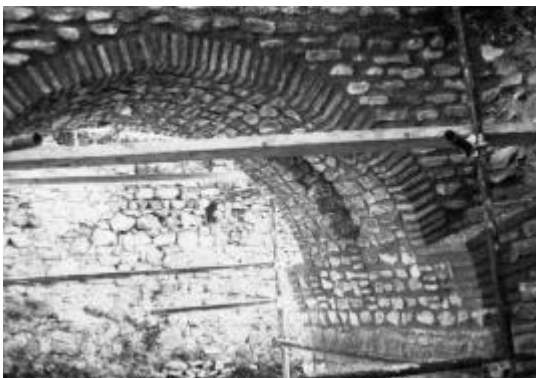
Figure 2: Partial reconstruction of the vaults.

With this information we were able to design[1] a reintegration which concentrated on both the structural requirements and reconstruction aspects. We engaged in traditional techniques as accurately as possible but did not carry out an integral reconstruction as it would have been excessive due to the high level of decay.

The reintegration of the arches meant the structure retained its *original static functionality* which for centuries guaranteed its stability and this also represented an *original value* that had to be preserved exactly as its material components.

The use of original techniques and materials also guaranteed the durability and longevity of the monument as they are totally chemically compatible with the ancient materials. Furthermore, conducting the work in this way meant that, should the structure need to be dismantled in the future no problems would be experienced. This is another reason why we avoided using modern concrete due to its great adhesiveness.

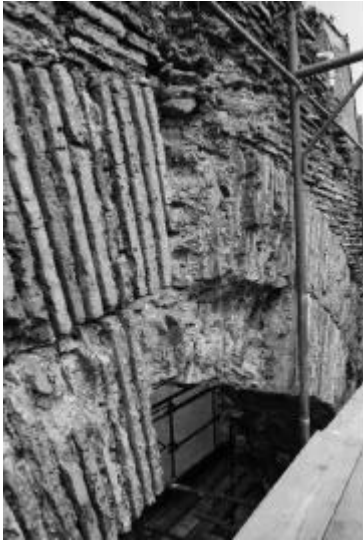
In the Cellomaio Baths the situation was dangerous because of some deep *lacunae* in the crown and in the haunch of an 8 metre wide arch constructed of roman bricks. However, the problem was to execute the reintegration while maintaining perfect cohesion between the new and

Figure 4: The arch before the reintegration.

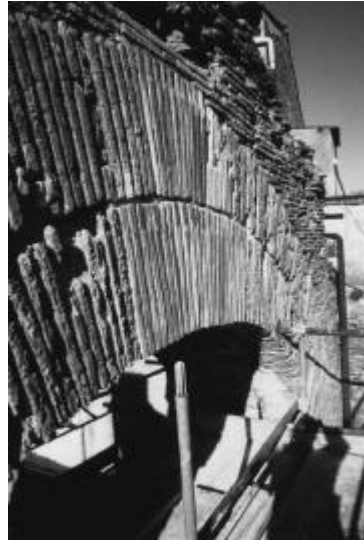
Figure 5: the arch after the reintegration.

original parts, also to preserve its structural continuity and original static function. We tried to do this by minimising the use of internal or external steel elements [2].

The wedge shape of the *lacune* in the crown prevent the reintegration sliding downwards. Lateral detachment is prevented by the insertion of specially shaped brick pegs inside the original nucleus to hold the two parts together. We managed, therefore to maintain perfect structural

continuity between the original and the new part without using metal components. In some parts of the haunches, where the reintegration was too thin to be shored-up by the simple contrast between the bricks, it was necessary to hold it in place by using thin stainless steel bars. This again allowed us to retain the original static functionality of the structure and has allowed us to re-establish its original architectonic image. This demonstrates how important the strict connection between the image and the structure was for the ancient roman contractors and so how important it is now that the structural reintegration is designed rediscovering the original architectonic image.

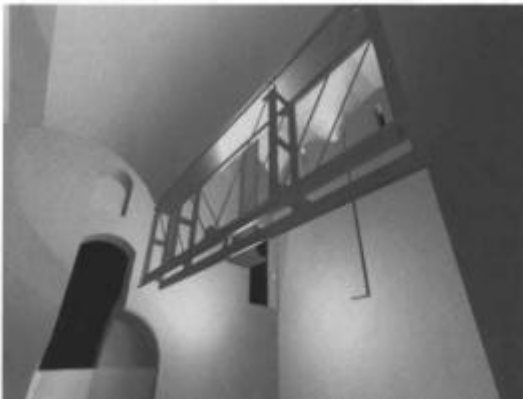
Figure 8: Rendering of our proposal (C. Carbone).

Our suggestion [3] was to support the wall on a high stainless steel truss that would leave the column behind it visible. We proposed to reconstruct only the half floor on the slab side where there was the column. The idea was to support the column on two transversal steel beams. This solution would have enabled us to carry out the work successfully, by highlighting the new structure and demonstrating the artifice of supporting a wall to allow the excavation underneath it.

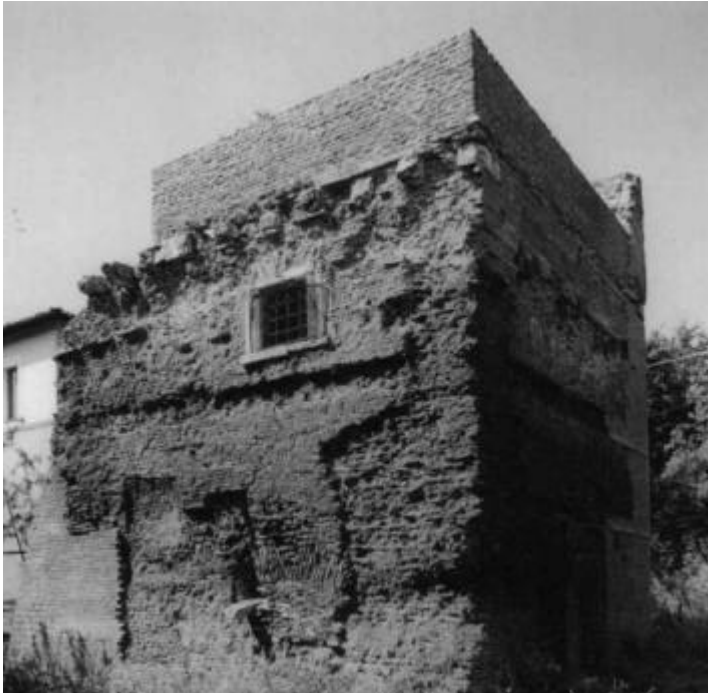
The existence of vertical cracks, especially in the corners, were dangerous due to the horizontal forces exerted by the ceiling tunnel vaults.

Figure 10: The building after structural restoration.

However, due to the history of the building an alternative solution was found. Considering that the building had at one time been a level higher, we decided to partially reconstruct the external walls to a height of about one metre. Inserting inside the reconstruction a longitudinal steel bar to allow a circular tie at the top level of the building. This solution meant that the original masonry, despite the addition of the structural measures remained unaltered. Furthermore, this also resulted in giving a suggestion of the original form, when the upper level still existed. This visual suggestion helps to give *legibility* back to an incomplete formal context that was hardly comprehensible but without the need for carrying out a total reconstruction.

This structural restoration has to be considered compatible with the original construction technique for a number of different reasons. Firstly, from a *philological* point of view because the new walls have been constructed from the same material as the original ones. Secondly,

from a *mechanical* point of view because the added structure has the same degree of stiffness as the original masonry. Thirdly, from a *formal* and *symbolic* point of view for the reason that we have already mentioned but especially for the *reversibility*. In fact, the additions stabilise the walls of the ancient structure performing its containing action due to the friction with the underlay masonry. This balances the horizontal forces produced by the vaults and any possible seismic action. The result is obtained without the need for steel bars in perforations.
