Kulla: A Traditional Albanian House Type in Kosovo

Sahar Rassam, Architect
Former Housing Coordinator and Municipal Housing Committee Chair,
United Nations Mission In Kosovo (UNMIK).

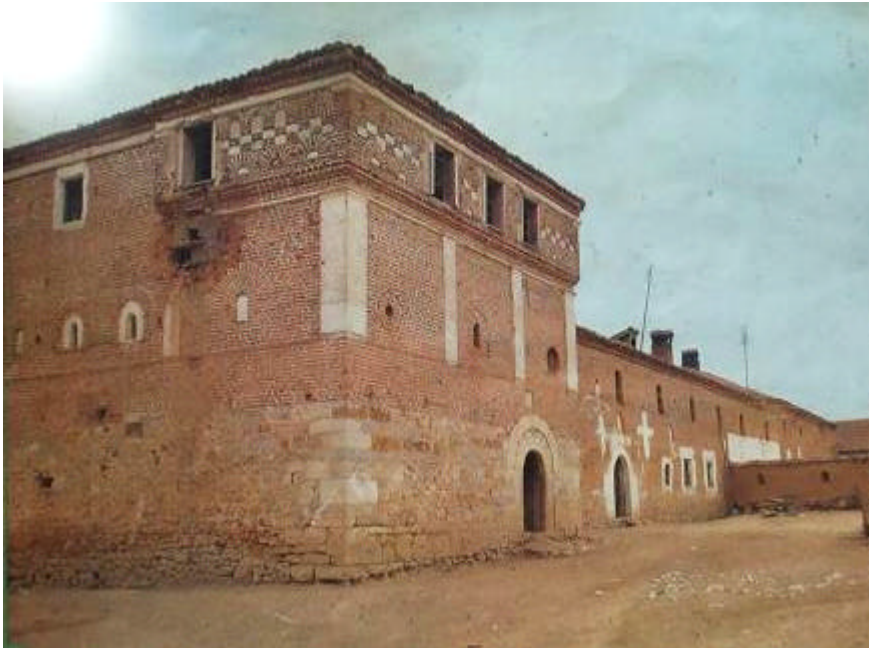
Figure 1: kulla of M. Gega, Gjurrakoc, Istog, as it used to be with the attached annex. Constructed of stone and brick. Taken from an old picture [2].

The kulla has either two or three floors and is mostly square in plan. They were usually utilized by the men of the family, while women and children lived in an attached annex having the same number of floors or less (Fig.1). Animals were kept in the ground floor and the upper floor was used by the men of the house and their guests. There are usually two entrances and staircases. One for the guests, from the main entrance, leading directly to the upper floor and the guest room without passing through the family private quarters. Another for the

The exterior walls are about one meter thick at the ground level and decrease upwards. They are constructed of stone (Fig.2), brick (Fig.3) or both (Fig.1) having the ground floor constructed of stone and the other floors of brick, with various patterns. The stones were excavated locally. The bricks are usually Harasan bricks, which were made of sand, chalk, water and a little cement, hand made and baked in kilns, or occasionally mud bricks. Interior walls are constructed of mud bricks with mud as the binding material and occasionally constructed of wood. The front door is through an arch opening in the wall. Small arched windows pierce the rather massive elevations. Many kullas have cantilevered parts and windows in the upper floor, constructed of the same material as the kulla, i.e. stone or brick with various decorative patterns, or of wood in the style of cardak with wooden arches and decorations (fig.4). There are also very small openings called (fringji) used for firing artillery and defense purposes. In fact, the architecture of the kulla, is as defensive as a fortress and must have provided excellent security during its history.

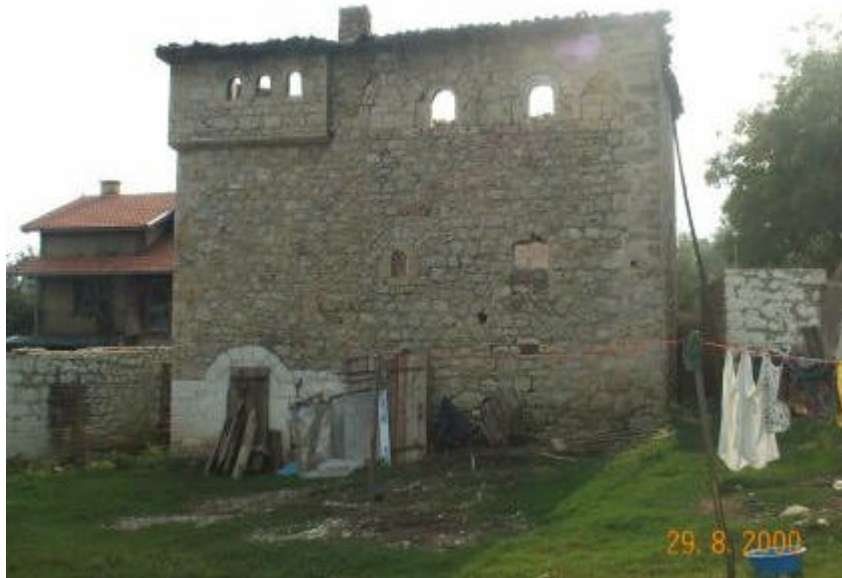
Figure 2 : Kulla of K. Fazlia, Lubozhda, Istog, constructed of stone [2].

- 1- Badly destroyed or reduced to part walls or rubble (Fig.11).
- 2- Outer walls in various rates of damage but nothing was left of the interiors and the roof (Fig.2).
- 3- Outer walls in good or repairable condition and need some restoration of the interiors and roof.
- 4- In a fairly good condition and are inhabited.
- 5- Altered and rebuilt and their facades had undergone significant changes (Fig.12).

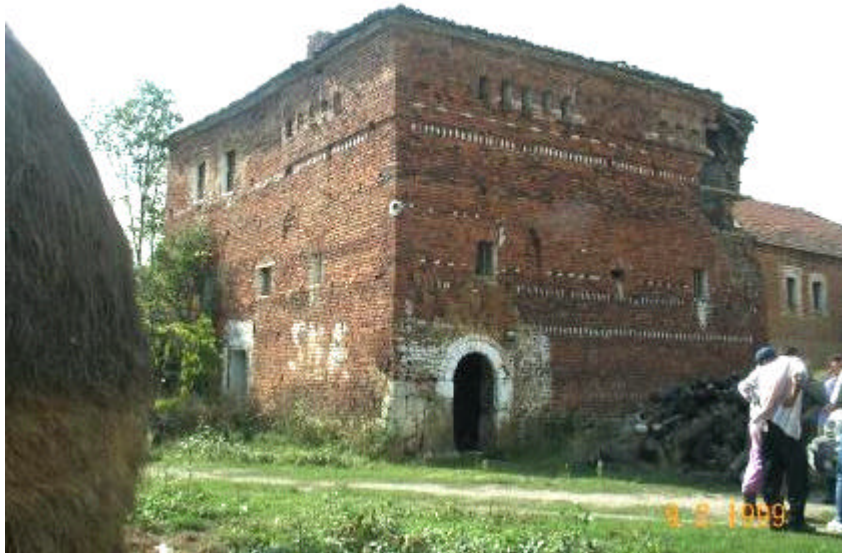
Figure 3 : Kulla of C. Ahmetaj, Zabllac, Istog, constructed of brick [2].

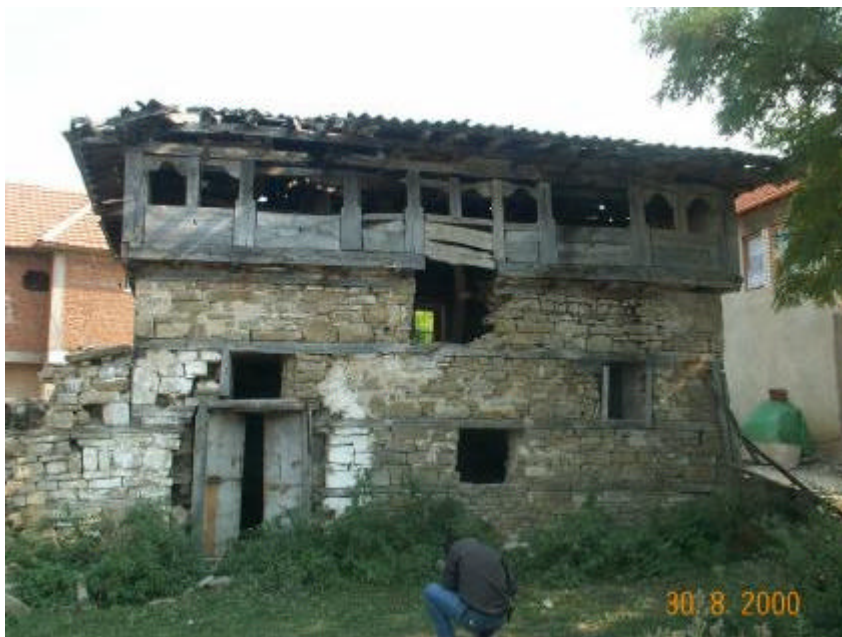
Figure 4: Kulla of S. Mata, Doberdol, Klina, with cardak style cantilever [2].

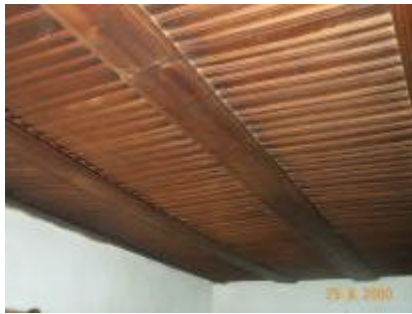
Fig. 5: inner ceiling [2].
Kulla of H. Maxharraj, Gramnik, Klina

The floors were constructed of tree trunks and the upper floor ceiling was covered from the inside with decorated wooden planks. The roof was topped with stone sheets which have later been mostly replaced with roofing tiles (Fig.6). Many details were incorporated in the design. Some kullas have the Qibla, a vertical niche in the wall pointing in the direction of Mekka and used for prayer. Certain rooms have fireplaces which were gradually blocked with birds' nests and later were built and closed. There are also wooden hangers attached to the ceiling above the fireplaces for drying clothes (Fig.7), built in wooden ornamented cupboards for storing coffee in the guests room (Fig 8), stone built-in boxes in front of windows and fringjis, stone sinks with an opening to the outside for drainage (Fig 9), and traditional eastern type toilets which were either built originally with the house or added at a later time (Fig.10).

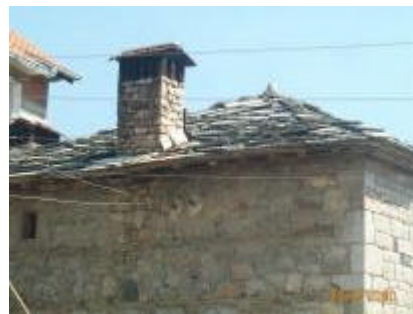
Fig. 6: stone sheet roofing [2].
Kulla of H.Maxharraj Gramnik, Klina

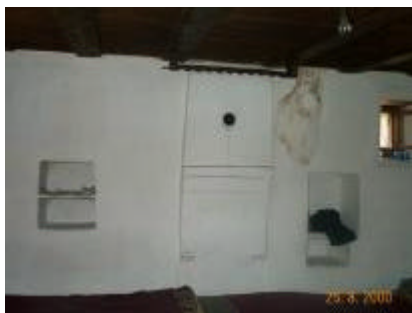
Fig. 7: closed fireplace with hanger [2]
Kulla of H. Maxharraj, Gramnik, Klina

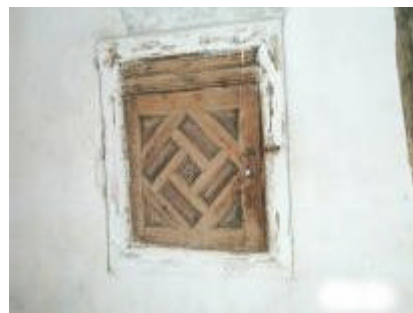
Fig. 8: built-in cupboard [2]
Kulla of U.Ukaj, Kaliqan, Istog

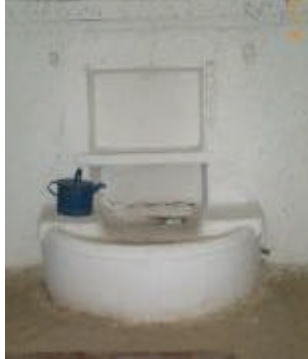
Fig.9: Stone basin [2]
Kulla of J.Jaku, Ranoc, Klina

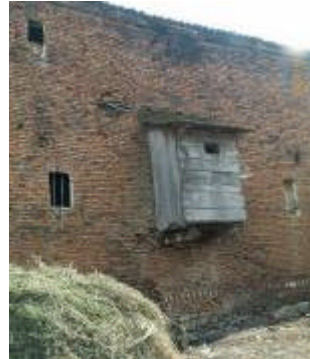
Fig.10: Added eastern toilet [2]
Kulla of C. Ahmetaj, Zabllac, Istog

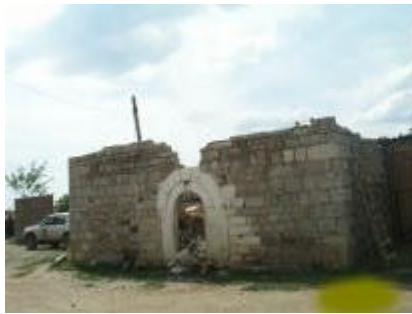
Fig.11: Badly destroyed kulla [2]
Kulla of F.Meta, Shushice e Ulet, Istog

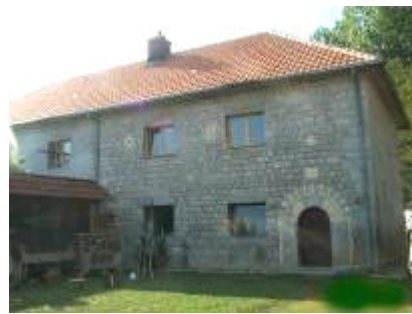
Fig.12: Altered and rebuilt kulla [2]
Kulla of N.Shatri, Tomoc, Istog
