MORPHOLOGY, STRUCTURE AND HISTORY – THE CASE OF THE UPPER FLYING ARCHES OF MALLORCA CATHEDRAL

P ROCA and J. L. GONZÁLEZ
Universitat Politècnica de Catalunya, Spain

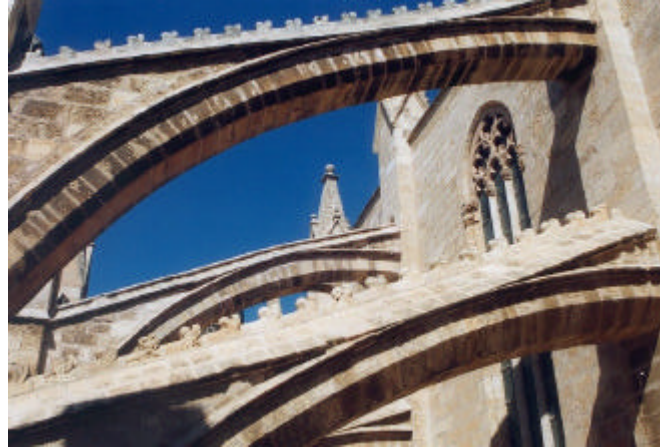
Fig 2.- Apparent deformation of flying arches

As already said, most of the flying arches of the building show today a remarkable deformed shape. This alteration becomes very apparent in the downward curvature acquired by the cornices (Figs. 2-3). The deflection of the cornices reaches $1/40$ of the arch span in some cases. This dramatic deformation may have created deep concern at certain (historical) time and led to propping some of the upper flying arches on masonry columns built over the lower ones. Three different flying arches, at least, were propped that way and remain so. On the other hand, the arches (under the cornices) do not show the important damage that should be expected to accompany a true large deformation.

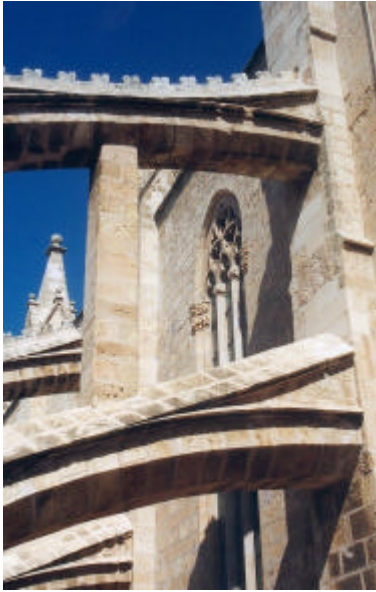
Fig. 3 – Flying arch propped on a masonry column
