ON SITE INVESTIGATION AND MONITORING OF THE “TORRAZZO” OF CREMONA

L. BINDA¹, C. POGGI¹, G. MIRABELLA ROBERTI², R. TONGINI FOLLI¹
Politecnico di Milano¹, University of Reggio Calabria²

The Torrazzo of Cremona, the highest masonry tower in Europe shows signs of mechanical damage which can proceed toward risky state. The authors have carried out on site and laboratory investigation which ruled out short time risk but suggested the necessity of a long term monitoring to study the progress of the damage.

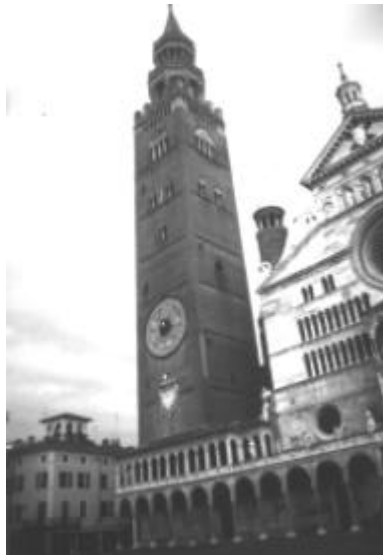
Figure 1: The *Torrazzo* of Cremona

The presence of a diffused crack pattern particularly on the West, on the East side of the tower and on the *Ghirlandina* can indicate high states of stress due to the dead loads, the temperature variations and/or to a slight leaning. The highest temperature variations certainly occur between the North and the Southern side. In fact, the Western and Eastern sides have a diffused fissuration with passing-through cracks starting from approximately 20m up. Important cracks appear also between 48 and 60m from the ground level (Fig. 3). Fewer cracks appear in the Northern side (between 27 and 40m and at the NE corner) and in the Southern side (between 14 and 27m).

The *Ghirlandina* shows the most important cracks on the buttresses and on the brick columns particularly on the SW corner. Also the internal part of the tower, along the staircase and inside the rooms shows a diffused crack pattern with some passing through cracks.

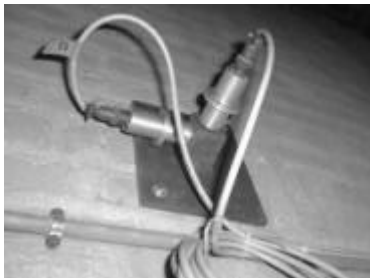
In order to measure the instantaneous speed and direction of the wind on the structure, 4 cup anemometers, coupled with a wind vane, have been installed close to the top (85 m), one on each of the four sides of the tower. The section location, the transducers distance from the structure and the fastening system have been carefully chosen, in order to reduce as much as possible the flow-structure interference in the measured signals. The dynamic wind response and the experimental identification of the structure vibration modes, accelerations are measured in 21 different points along the tower. The modal deformations, numerically evaluated, allowed to select the optimal locations of 7 measurement sections, positioned at different elevations (see Fig. 9). In each section, three accelerometers can be fixed: two on the West wall (N-S and E-W measuring axis), and one on the South wall (E-W measuring axis). In this way, by means of proper elaboration, it is possible to distinguish flexural vibration modes in different planes from torsional ones (Fig. 5).

Figure 5: Servoaccelerometer

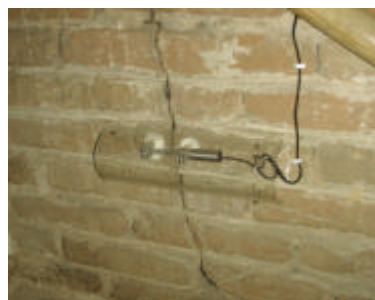
As previously mentioned, the masonry temperature is monitored in 22 different locations by means of RTD transducers. The most significant cracks of the structure, at different heights and mostly in internal locations, have also been monitored by means of 15 LVDT displacement transducers, giving continuous static information on the structure status and allowing as well dynamic monitoring in the full frequency range of the tower dynamics (Fig. 6).

Figure 6: LVDT
