THE BISHOP PALACE IN DUBROVNIK: STRUCTURAL ANALYSES AND PROPOSAL OF REMEDIAL MEASURES

A. BONCI¹, A. VISKOVIC²

SUMMARY

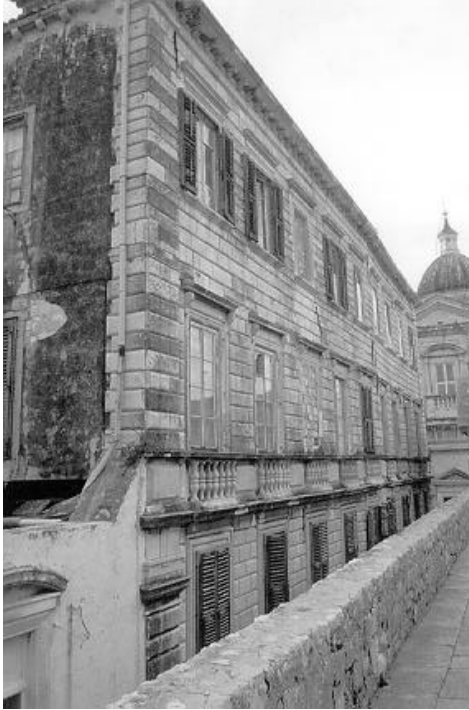
Fig. 1 : North Façade

good values of resistance, but it was also noticed that the heterogeneity of the masonry due to frequent modifications, and diffuse damage caused by the seismic action, contributed to weaken the structure in large areas. Cracks are now visible near most of the doors and lintels, and on the East Façade. A particular problem was detected on the North façade (Fig. 1), where parapet walls, built in the 18th century, are not actually connected to the structure and do not co-work with the rest of the wall, weakening the façade at this level. Cracks on the cornices under the balustrade of the second storey are now visible under almost all of the windows (Fig. 2). In the preliminary project elaborated by University of Zagreb several interventions were proposed, not only to strengthen the structure, but also to permit the new activities that are going to be performed in the building and to recover its original aspect. Thus, in the preliminary project, the demolition of the parapet walls of the balustrade of the first storey of the North façade was proposed, in order to return the façade to its original 17th century aspect.

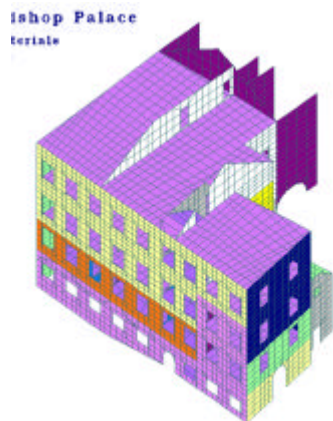
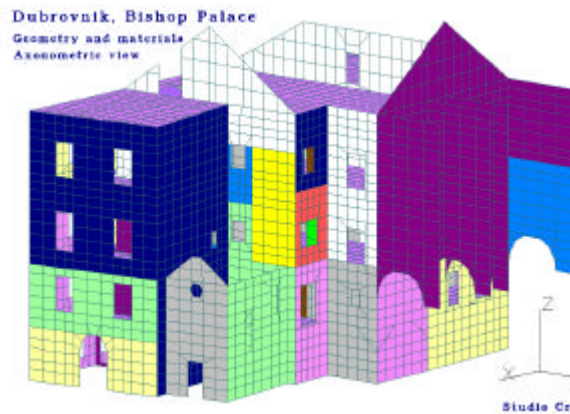
Fig. 3 : The F.E model

A finite element model of the whole building was arranged in order to study the structural behaviour under dead loads and during seismic actions (Fig. 3, 4). Numerical analyses were then performed using the “SUPERSAP” software from Algor Inc.

No significant problems were detected as regards vertical static loads; whilst a special care was needed for the study of the effect of seismic actions.

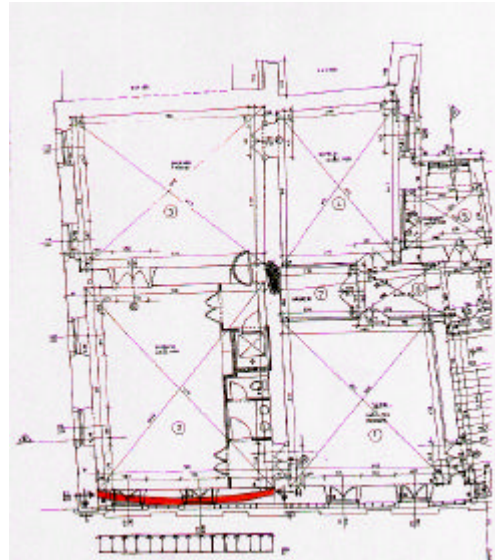
Fig. 10

of the façade respect to the situation explored in the previous analysis:
