SALVAGING THE CAPILLA DE LAS ÁNIMAS IN MEXICO CITY

E. OVANDO-SHELLEY¹, E. SANTOYO²

¹Instituto de Ingeniería, UNAM, Mexico City, ²TGC Geotecnia, Mexico City

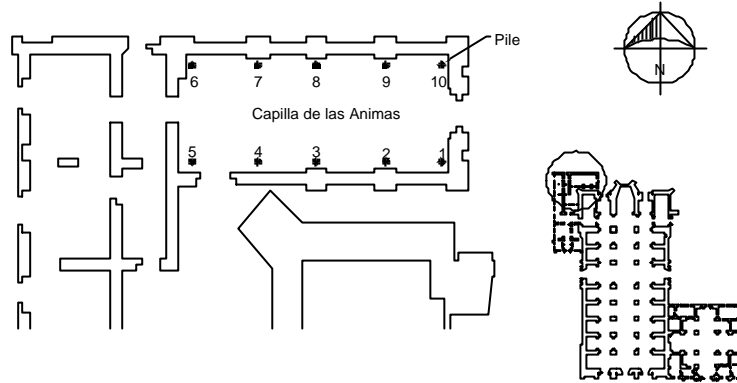
The Capilla de las Ánimas in Mexico City is a single nave vaulted chapel built in 1725 on the northwestern portion of the Metropolitan Cathedral's atrium, (Figure 1). It is 19.54 m long, 9.31 m wide and 9.25 m tall. Regional subsidence induced differential settlements in the chapel, starting on the mid XIXth century which resulted in severe tilting and cracking. Damages accumulated during the XXth century and, in the early 70's, an underground train was built along its northern wall, only a few tens of centimetres away from it, which resulted in further damages to the chapel. Underexcavation of the Metropolitan Cathedral, which was designed to induce settlements of almost one metre in the vicinity of the Chapel, would have damaged it even more [1]. Given its inherent structural weaknesses, the survival of the chapel could only be guaranteed by isolating it from the displacement fields generated while underexcavating the Cathedral.

Figure 1 : Location the Capilla de las Animas
