The unusual dome of the Cappella Emiliana on the Island of San Michele in the Venice Lagoon

Alberto Lionello¹, Claudio Menichelli²,

Abstract The Emiliana chapel, built between 1528 and 1543, is hexagonal in shape and is surmounted by a hemispherical dome. The most distinctive feature of the construction is its complex roofing system. This consists of two hemispherical caps connected by a central pillar. The inner cap is made of brick masonry and the outer dome of blocks of Istrian stone, arranged in horizontal courses. The masonry central pillar is connected to the outer shell by iron tie-rods.

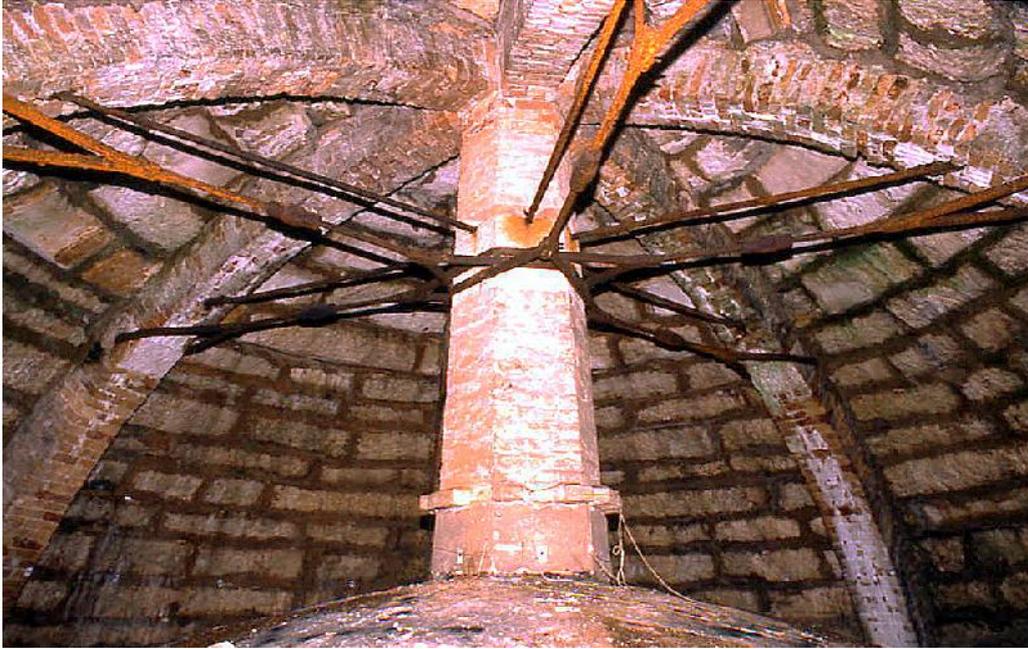
Fig. 3 - The inside of the dome between the two caps (p. S. Petrelli, I. Sartori, 1996).

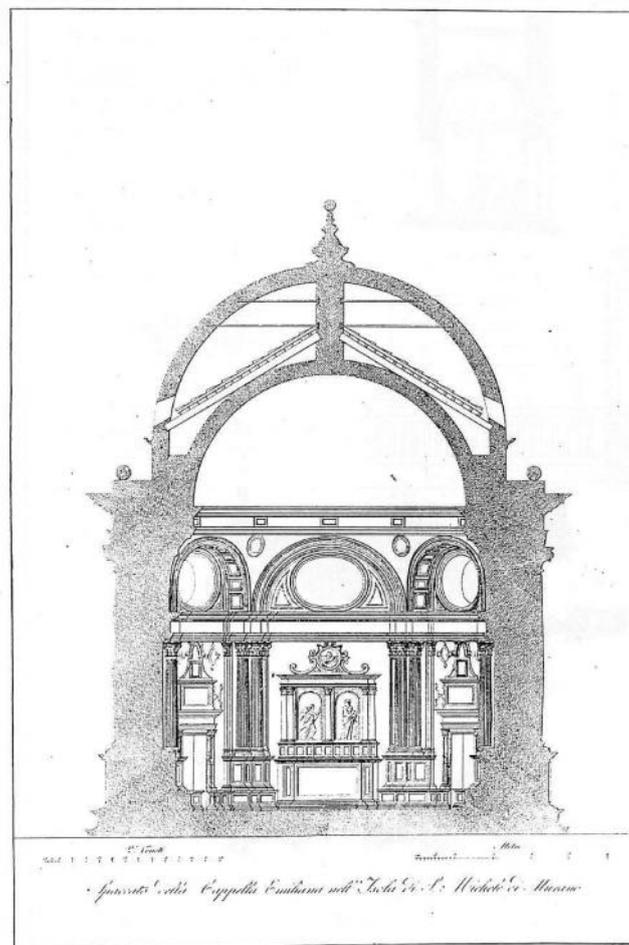
Throughout its history, the external cap of the chapel dome has always had a poor record as a waterproof cover. Just twenty years after the building was completed the joints in the dome began to need regular refilling; witnesses to the phenomenon include Sansovino, whom the Procuratori appointed to supervise the maintenance of the building. In response to this lack of efficiency as a rainproof protection, it was decided to insert a sloping tiled roof system radiating from the pillar between the two caps, to intercept any rainwater leaks and carry the water away before it could damage the internal calotta.

Fig. 5 - The Cappella Emiliana main section. Drawing from: Cicognara L., Diedo A., Selva A., *Le fabbriche e i monumenti più cospicui di Venezia* (1834-40).

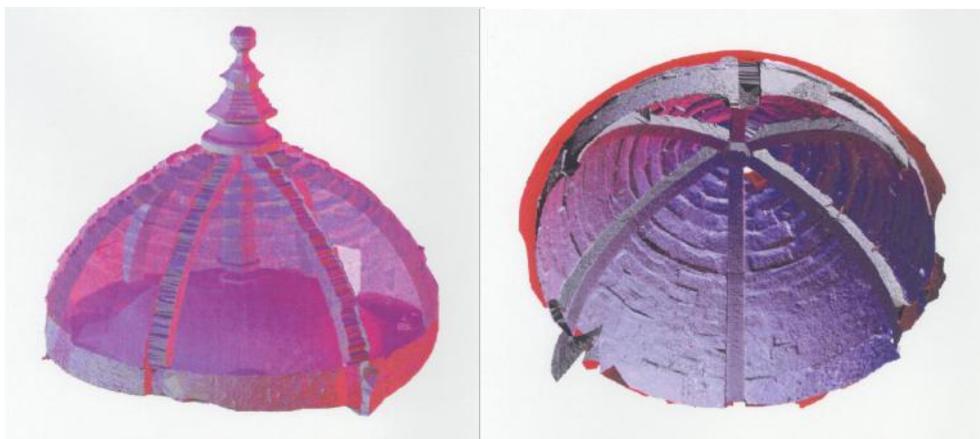
Fig. 10 – The laser-scanning modelling of the dome (SAT Survey 2002).

For reasons of conservation, prompted by the general wish to maintain the historical layering testifying to all the phases in the life of the building but also by the desire not to reduce the resistant components in play, it was decided to maintain the consolidation measures that had accumulated over time and which had resulted in the structural confusion described above. It was however considered necessary to restore order to the roofing system, separating the independent structural elements and enabling them to act autonomously, and creating hierarchies in the structural role of the resistant elements. Priority was given to recreating the original *tholos*-type behaviour of the dome by ensuring maximum connection and collaboration between its constituent blocks. When elements were being repositioned careful attention was paid to every aspect of the geometry of the dome. In particular, blocks were replaced not only with reference to the usual precautions of numbering and marking all items before removal but exact radial repositioning of the rings was guaranteed by reference to a highly accurate three-dimensional survey carried out with a combination of topographic, photogrammetric, direct and laser-scanning techniques.

Special attention was paid to the interface between the outer cap and the ribs. In previous operations these spaces had been filled with chips of brick and mortar. Any stress or deformation was absorbed in part by the *tholos* structure and partly by the structure of webs and ribs, depending on their relative rigidity. The two structures did not have compatible deformations, however, and when the structural component of the ribs came into play it introduced deformations in the circular rings of the *tholos*, and jeopardized their stability. It was therefore decided that the consolidation project should establish a hierarchy for the order in which the structures came into play; first the dome must function as a *tholos*, as in the original conception, and only later, if this proved structurally inadequate should the ribs come into play and the segments of the cap function as webs. This principle was put into practice by filling the joints between the dome and the ribs, just to the edge, with relatively elastic mortar; this enables the stresses between the two structures to be transmitted only in the presence of serious deformations caused by the loss of efficiency of the *tholos*.
