Wise practices for coping with
BEACH EROSION

Anguilla

FORCES TO BE RECKONED WITH

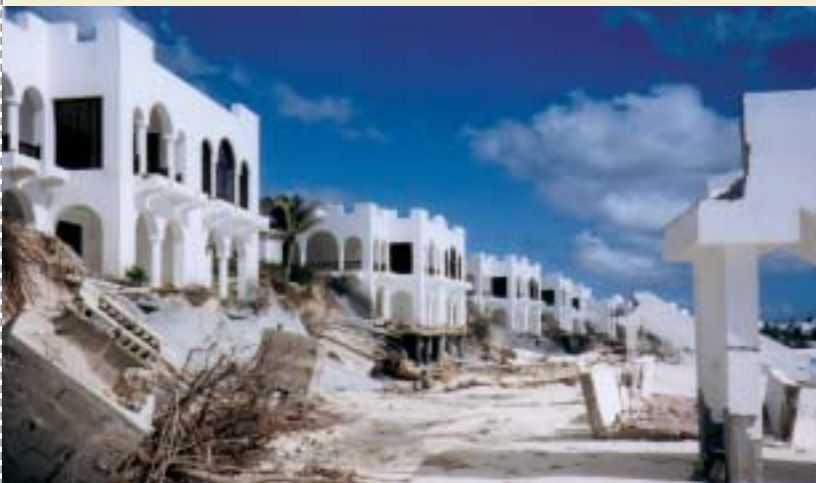
(left) Maunday's Bay after Hurricane Lenny in 1999. Hotel villas were undermined and stairways leading over the once extensive dunes were left as isolated monuments
